Last update: 2021/10/19 07:03	techtalk:ih:body20 http://www.sportsterpedia.com/doku.php/techtalk:ih:body20
-	<u> </u>

IH: Body Parts

1973-L1974 Rear Fender Reinforcement Bracket

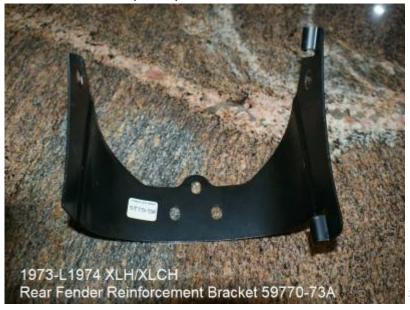
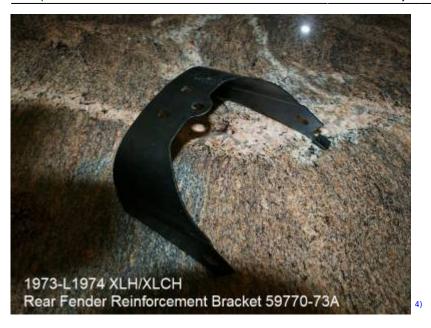
Pics of the bracket (uncut):

- Beginning with late production XL and XLCH models during March of 1974, a spot-welded reinforcement section has been added underneath the fender at the license plate bracket mounting holes. This was done to strengthen that area on the fender where the security system alarm is mounted to protect against cracking of the mounting holes in the fender. 1)

- A bolt on version was made available for Early 1974 Sportster models as a replacement on models
 that had already left the factory before this upgrade was done. It was recommended that the
 dealer install the bolt on version on all 1973 and 1974 models that were equipped with the security
 system.

- The bracket (59770-73A) had to be modified at the dealership to fit Sportster models where the bracket (59714-74) for FX and FXE models were a bolt and go. The Sportster bracket was made with tabs on the ends that had to be cut off with a hacksaw to allow for the tail light wiring. ²⁾
