## IH: Engine Mechanicals - Sub-01A

# Sprocket Cover Dowel Hole (Case) Repair

Article by Hopper of the XLFORUM <sup>1)</sup>

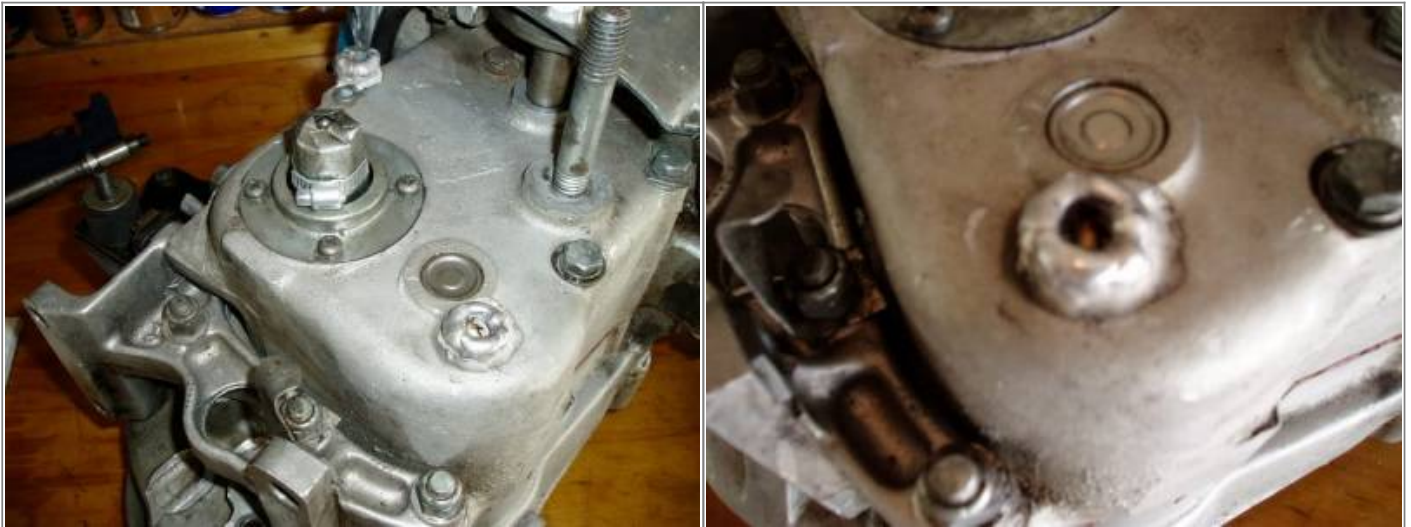
- When it came back from the aircraft welder it looked like the pics below.
  - Amazingly, there was no big blob of weld but two tiny little rings, still with the (rough) hole in the middle. His TIG welder can weld aluminum .010" thick.

- The gearbox shafts and bearings were left in place during welding to help stop distortion of the cases.
  - He pre-heated the cases gently with a torch and then he would put a ring of weld on, let it cool off, repeat, repeat repeat etc.

- Notice how he welded around the screw next to the top hole but did not go over it. And the 1/4" threaded hole in the middle was still useable. <sup>3)</sup>

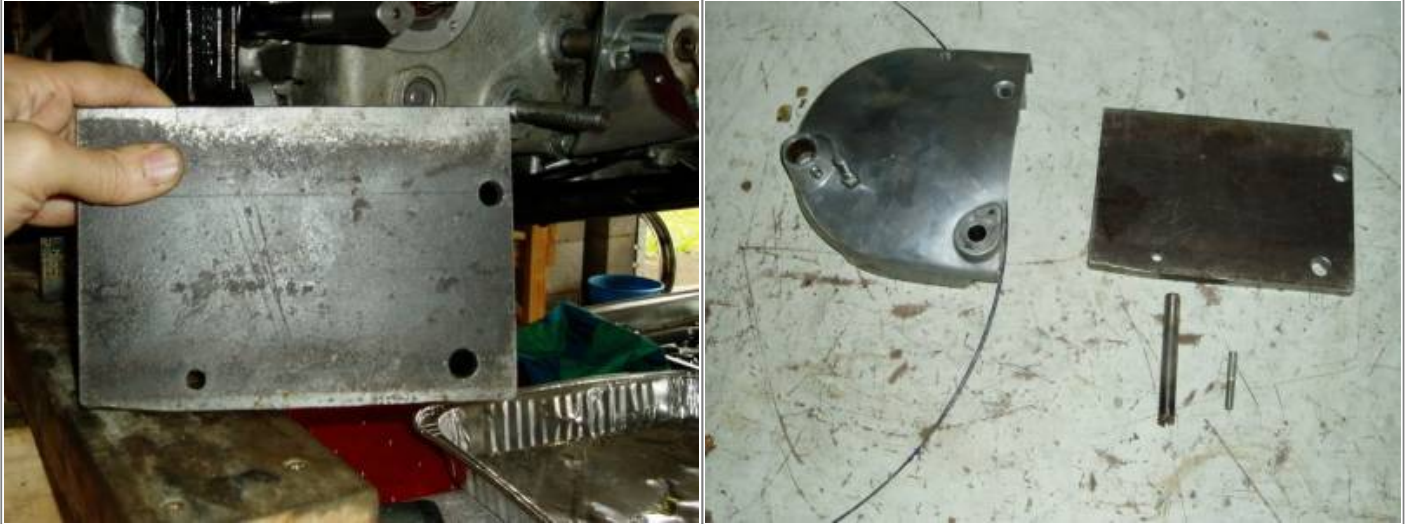
Drill jig made from a half-inch steel plate to guide the drill <sup>4)</sup>

- I made the jig by first drilling the hole to match the blind lower dowel hole in the sprocket cover, put the dowel in place and then drilled the footpeg stud hole by putting the sprocket cover over the plate and drilling down through it. Then the same for the top hole.
- I also sleeved the sprocket cover down with a steel sleeve so the hole for the footpeg stud was a tight fit and would take most of the weight in future.

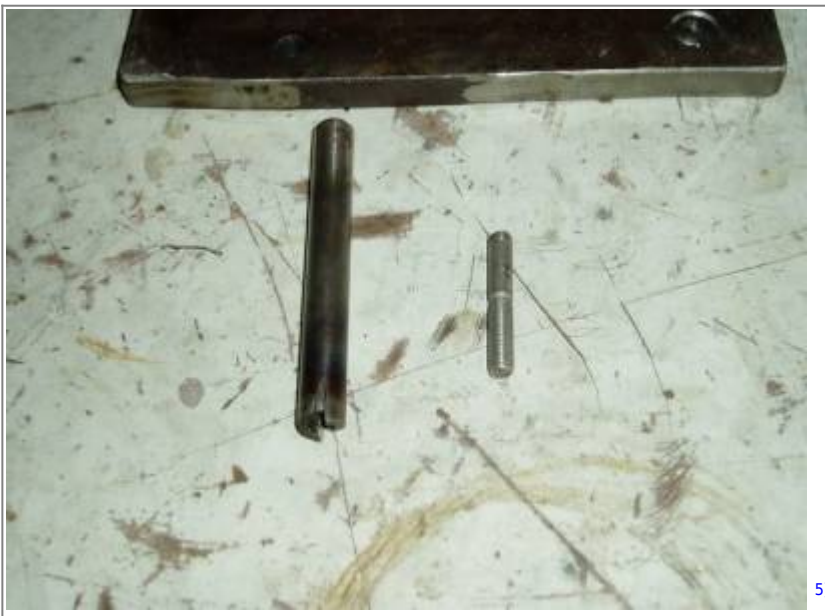
- Because the top hole has a 1/4 bolt running through it, and the weld was off centre, I made a special drill/cutter out of 7/16" silver steel. It had a 1/4 inch hole up the centre so it could fit over a threaded stud screwed in the hole. I cut two flutes on the end of it with an angle grinder so it is like a milling cutter, or flat-nosed drill. Finished it off on the pedestal grinder. I then flame hardened it with the oxy torch. Heated it cherry red then quenched in oil. Then tempered it to a light straw color and quenched again.

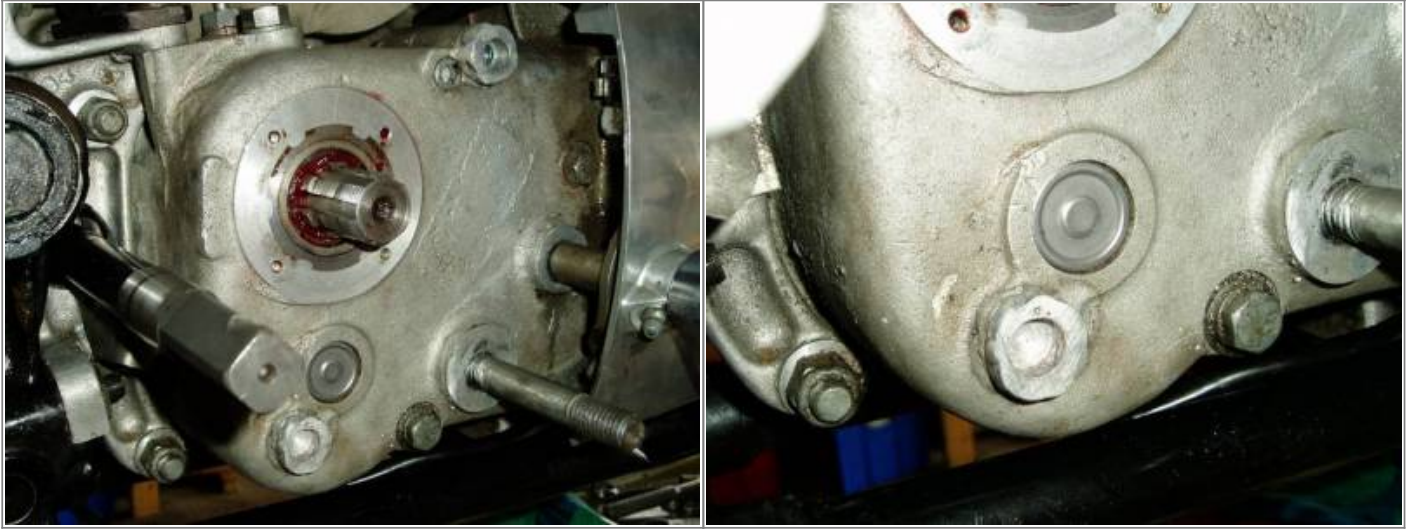
Using an electric drill (and proceeding very carefully), came up looking like this. <sup>6)</sup>

- In the final fit up, I made custom dowel pins and fitted them with a small file and some bearing blue so they are tight as tight and wont work loose again.
- I also drilled and tapped that top stud out to 5/16 for more strength and also plan to add a steel angle bracket from the top of the sprocket cover to the two bolts on the top of the gearbox near
