## REF: General-MSR 07

# Diagnosing Catastrophic Engine Failure in Evo Engines

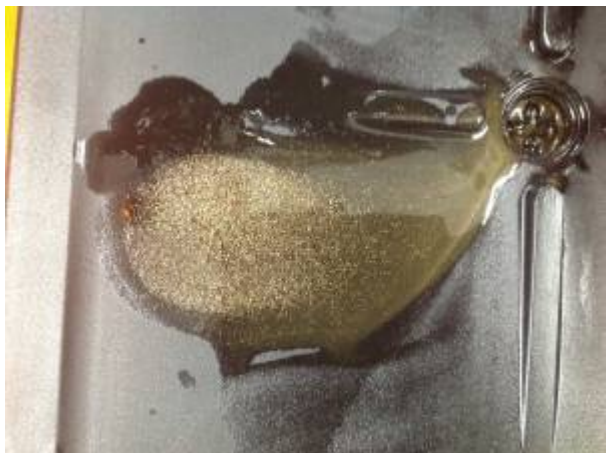
If something like this comes out when you do an oil change, find out if it's metal or brass / bronze and start diagnosing where it came from.

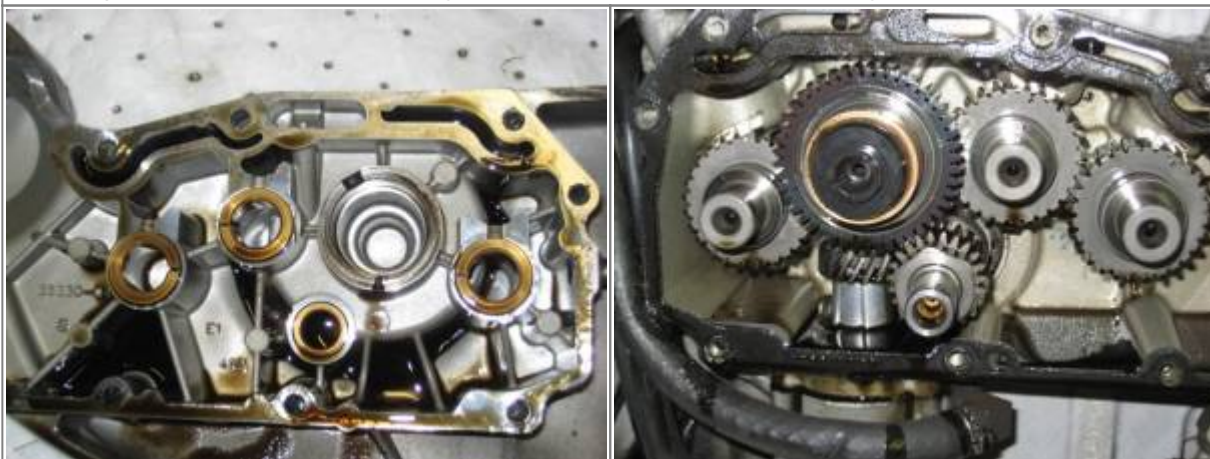
Spun #2 outer cam bushing, 2006 cam cover. Heat coloring on front of cam.<sup>13)</sup>

- **Repair.** When the bushings spin in the cases, they don't leave a perfectly round bore. As they spin, they rip/ream some of the bore I.D. and may move the bore center.

Finding that center with oversize bushings should be done by a qualified machine shop.

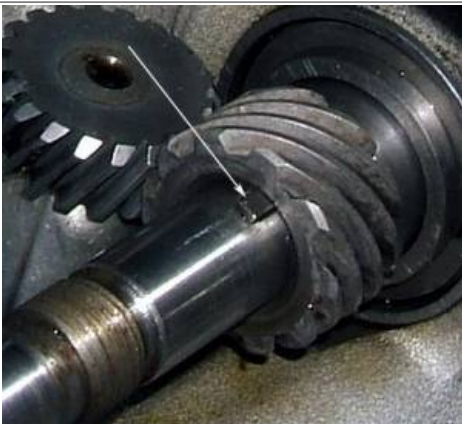
Pinion key location <sup>18)</sup>	Condition of key after gear spins <sup>19)</sup>	Pinion gear spun (app 90°), stopped and still turned the cams from new location <sup>20)</sup>

<p>The pinion gear is located by the little nub of the oil pump drive key that you see sticking out. With high valve spring pressures, this nub often shears off, sending pistons crashing into valves. Avoid this issue by torquing the pinion nut to 70lb-ft. Be sure to use Loctite red on the threads per the manual.</p>

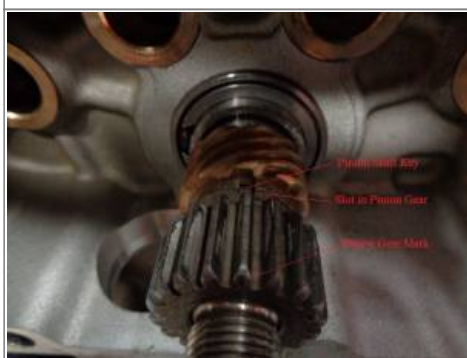
Pinion gear slot aligned with pump gear face. <sup>22)</sup>

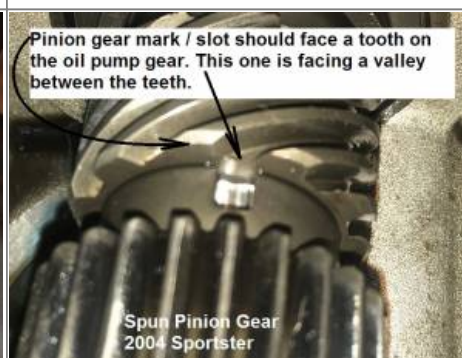
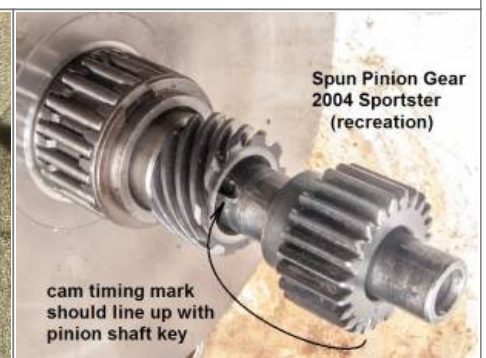
If the pinion gear slot is facing a valley (between two teeth) on the pump gear, the pinion key (at least the part that holds the pinion gear) has sheared.

And the pinion gear has turned to some degree out of time with the crankshaft.

Spun pinion gear. <sup>23)</sup>

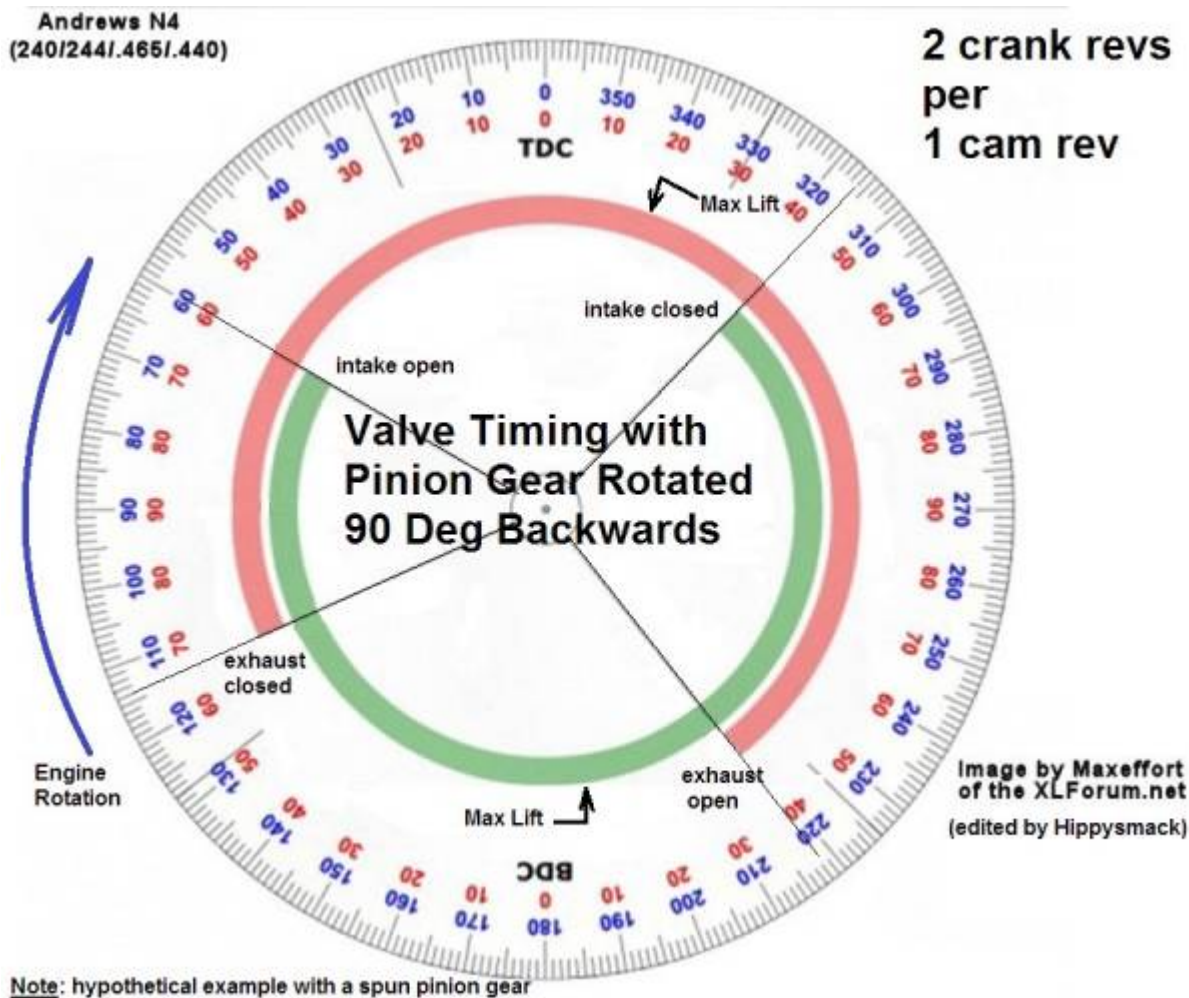
The intake cam lobe center (point of max lift) is now resting at app. 8° after BDC.  
 On the next TDC event (360° of crank movement), max lift (180° of cam movement) on the intake valve will occur at 8° after TDC.  
 Next TDC event, max lift will be back at 8° after BDC.

The exhaust cam lobe center (point of max lift) is resting at app. 20° before TDC.  
 On the next TDC event (360° of crank movement), max lift (180° of cam movement) on the exhaust valve will be app 20° before BDC.  
 Next TDC event, max lift will be back at 20° before TDC.

So in this example, the intake valve should take the first hit before the exhaust valve would due to the proximity to the piston during rotation.

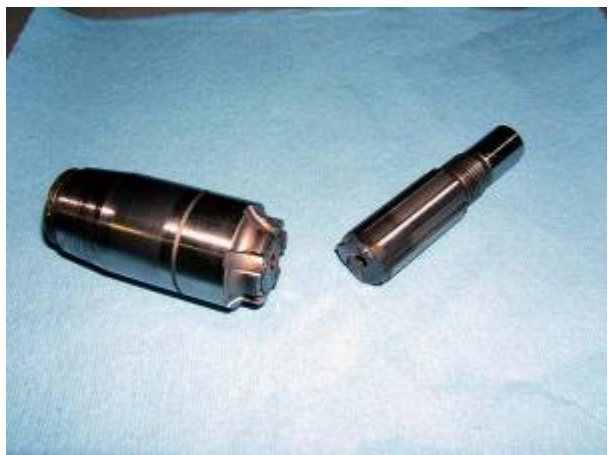
Here's the worst symptom of an out-of-true crank. The pinion shaft snapped. <sup>27)</sup>

- Safe installation of the pinion gear requires a pinion locking tool as well. <sup>26)</sup>  
If you hold the crank by any other method while removing or installing the pinion nut, you apply torque through the crank from one side to the other.  
And they're not designed to hold much torque that way, you risk knocking it out of true.
