Tech Article

TA0022: Transmission to Primary Oil Transfer

Reference	TA0022
Last Modified	2017-09-27
Models	2014: FLHP, FLHR, FLHR 103, FLHRC, FLHRSE, FLHTCU, FLHTCU TC, FLHTCUTG, FLHTK, FLHTK 103, FLHTK SHRINE, FLHTKSE, FLHTP, FLHX, FLHX SHRINE, FLHXS 2015: FLHP, FLHR, FLHRC, FLHTCU, FLHTCU TC, FLHTCUL, FLHTCUL TC, FLHTCUTG, FLHTK, FLHTK SHRINE, FLHTKL, FLHTKSE, FLHTP, FLHX, FLHXS, FLHXSE, FLRT, FLTRUSE, FLTRX, FLTRXS 2016: FLHP, FLHR, FLHRC, FLHTCU, FLHTCU TC, FLHTCUL, FLHTCUL TC, FLHTCUTG, FLHTK, FLHTK SHRINE, FLHTKL, FLHTKSE, FLHTP, FLHX, FLHXS, FLHXSE, FLRT, FLTRU, FLTRUSE, FLTRX, FLTRXS 2017: FLHP, FLHR, FLHRC, FLHRXS, FLHTCU, FLHTCUTG, FLHTK, FLHTK SHRINE, FLHTKL, FLHTKSE, FLHTP, FLHX, FLHXS, FLHXSE, FLRT, FLTRU, FLTRX, FLTRXS 2018: FLHP, FLHR, FLHRC, FLHRXS, FLHTCU, FLHTCUTG, FLHTCUTG ANV, FLHTK, FLHTK ANV, FLHTK SHRINE, FLHTKL, FLHTKSE, FLHTKSE ANV, FLHTP, FLHX, FLHX ANV, FLHXS, FLHXS ANV, FLHXSE, FLRT, FLTRU, FLTRX, FLTRXS, FLTRXS SE
Category	Transmission

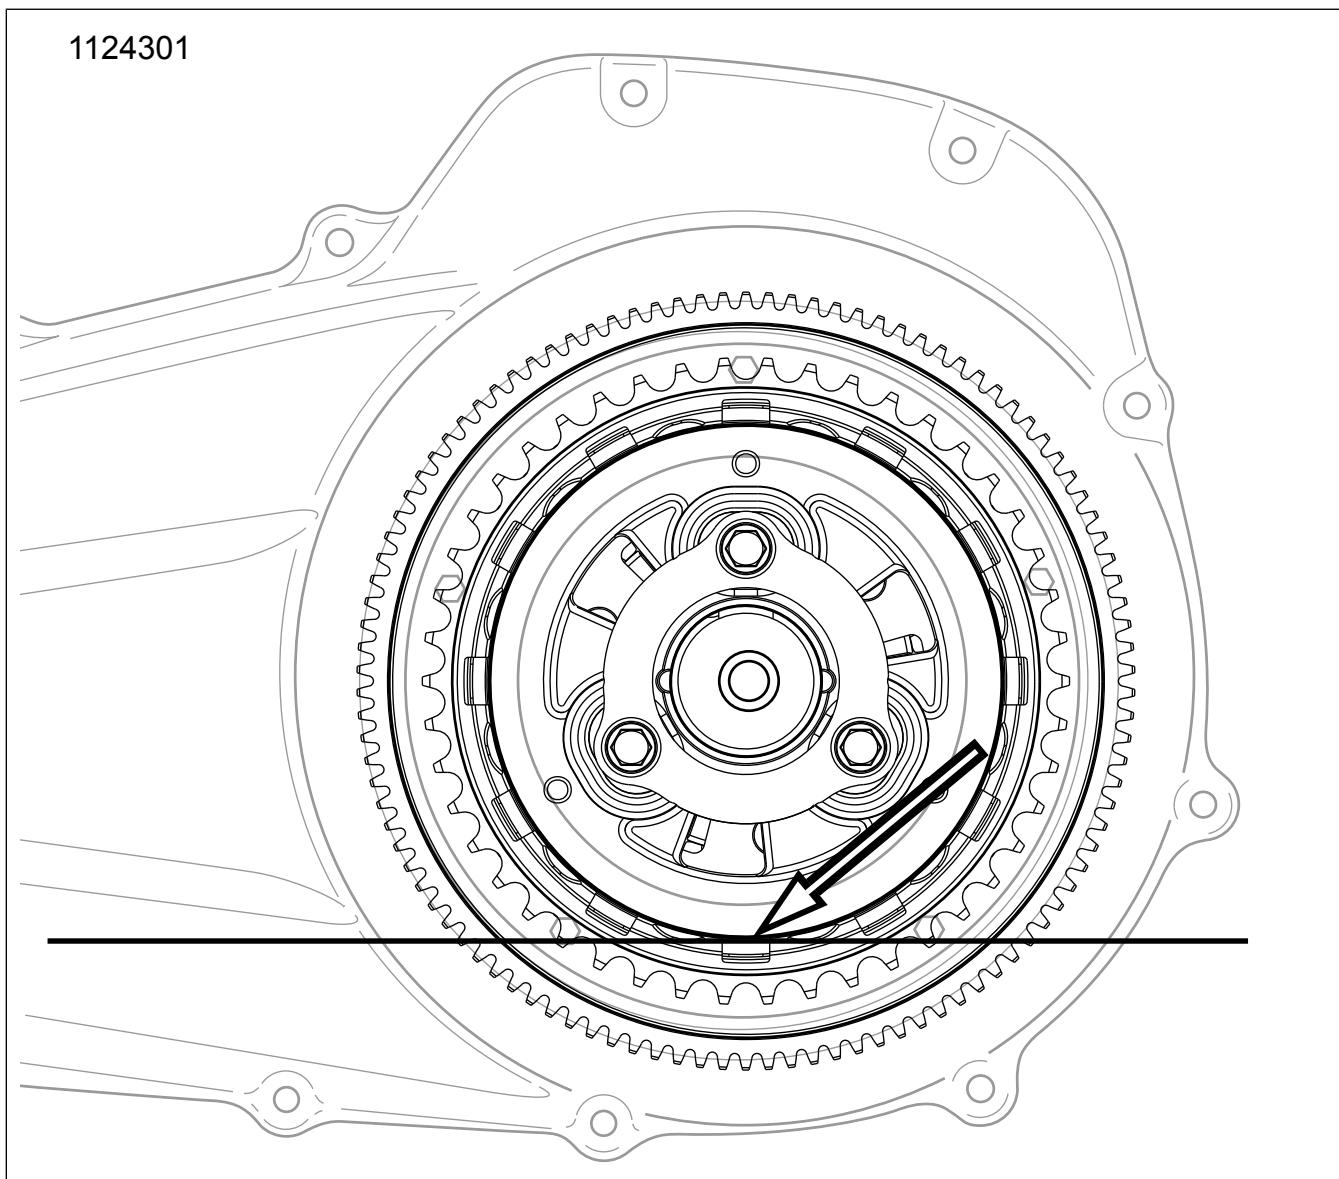
Figure 1. Primary Lubricant Level

During service intervals, customers or dealers may find oil level in the primary above the clutch cover opening. This also is accompanied by low transmission oil level.

This is occurring because oil is transferring from the transmission cavity to the primary cavity. Harley-Davidson has confirmed some vehicles show higher amounts of transfer than expected. While some oil transfer can occur, instances where 150 ml (5 fl oz) or more have transferred in less than 8,000 km (5,000 mi) should be reviewed per the direction.

Refer to Figure 1. Check the primary and transmission oil levels and adjust the oil volumes as needed. Verify oil levels again in 1,600 km (1,000 mi).
