BATTERY SUPPORT BRACKET / EARLY 1974 FL, FLH-1200

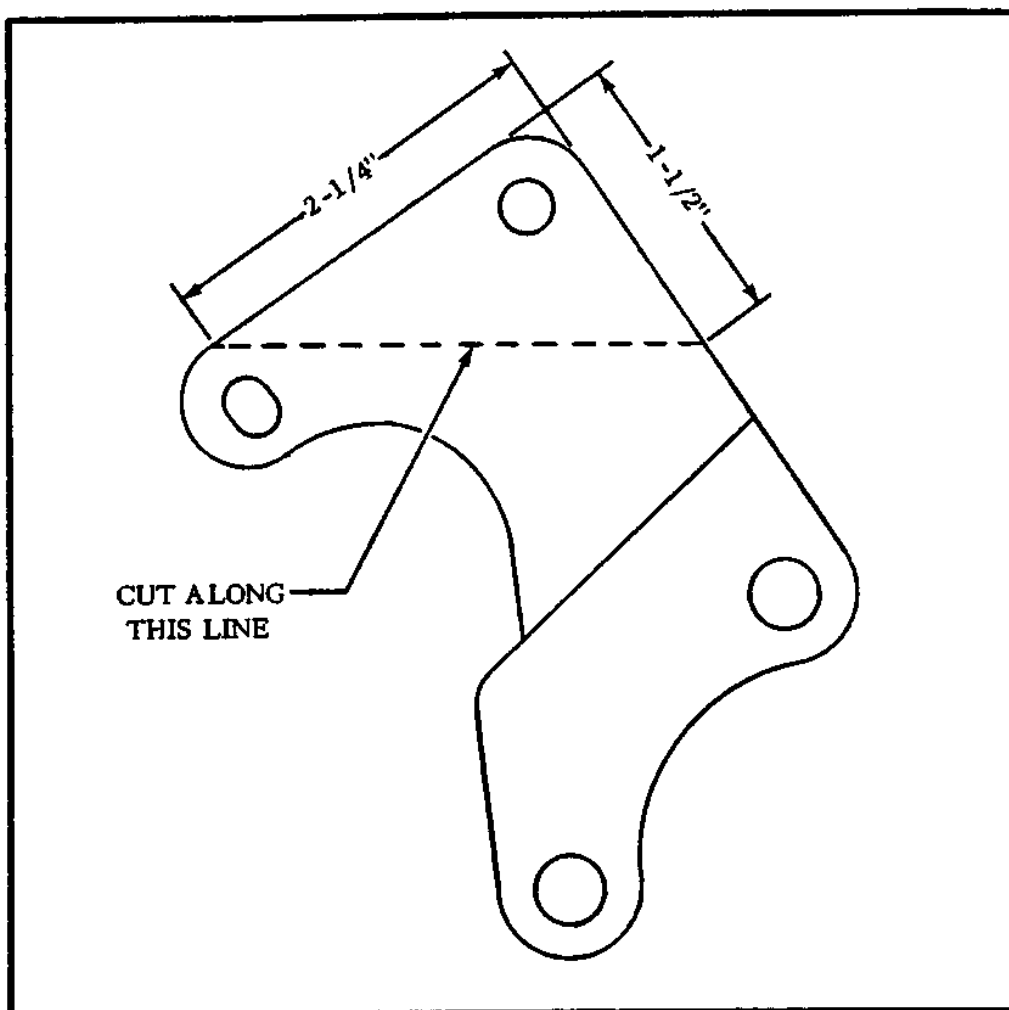
All 1974 FL, FLH-1200 models produced before December 14, 1973 should be checked for interference between the battery support bracket and bottom of battery.

If insufficient clearance exists, the battery can be damaged resulting in acid damage to the motorcycle.

Remove bracket from motorcycle, cut off corner as shown in diagram, and reinstall bracket on motorcycle.
