IGNITION SWITCH / 1974 FX, FXE, XL, XLCH

HARLEY-DAVIDSON MOTOR CO., INC.

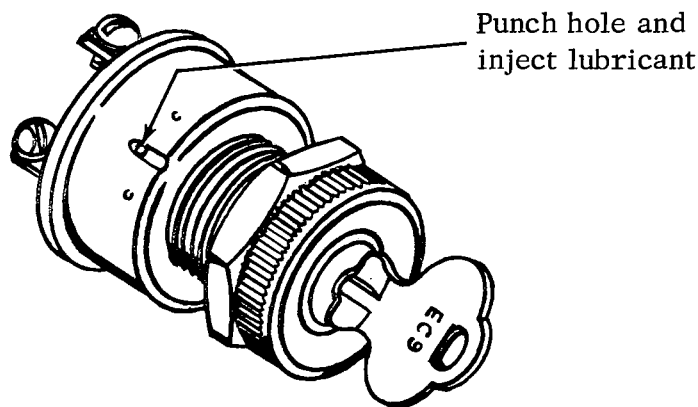
Due to a production oversight on 1974 models, lubricant was omitted on the ignition key switch indexing plate, which could cause the switch to bind.

The lubricant can be injected into the switch after removing the switch from the vehicle and punching a small hole in the notched area as shown below.

To remedy or prevent a binding problem, lubrication with a silicone lubricant is recommended.

If this lubrication injection doesn't remedy the binding, inject lubricant into the 1/8" tumbler lubrication hole located in the mounting nut thread area.

Continued binding indicates switch is defective and should be replaced using Part No. 71500-59A.
