**CLUTCH PUSH ROD BEARING THRUST WASHERS / 1200CC MOTORCYCLES**

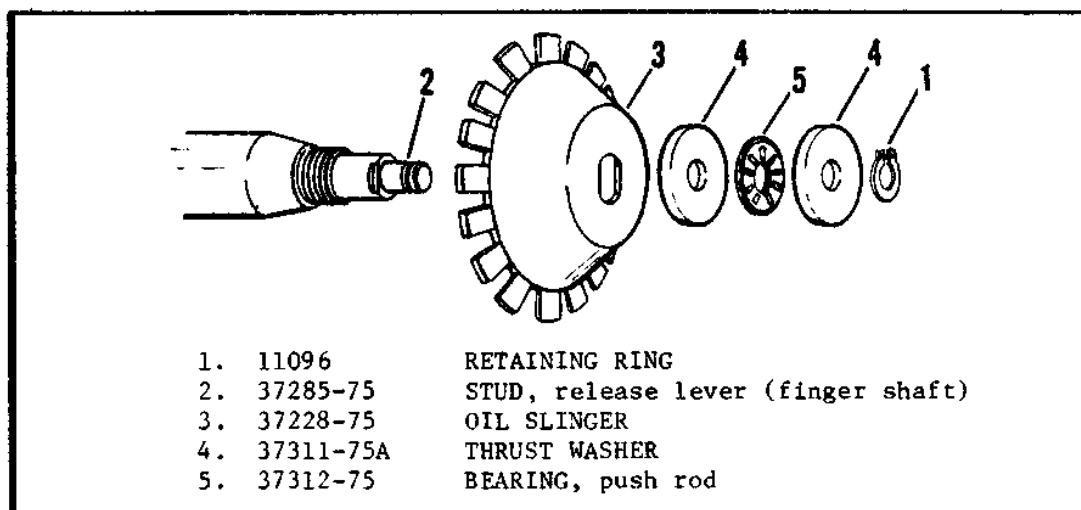
Clutch Push Rod Bearing - Exploded View

A limited number of FL/FX transmissions were assembled with improperly heat treated thrust washers, part number 37311-75A, in the clutch push rod bearing. (See illustration) The suspect transmissions fall within the number range of W4000 to W6000.

1. Determine whether the motorcycle falls within the appropriate VIN range.
2. Check the transmission number (located on the right front of the transmission housing). If the number is within W4000 and W6000, check for the faulty thrust washers as outlined in Step 3.
3. Remove the transmission filler plug. Using a file or similarly sharp tool, try to scratch the surface of the outer thrust washer. If the surface is scratchable, you must replace both thrust washers. If not, or if the thrust washers are of the earlier style (smaller in diameter), you need not replace any.

If bearing fails due to soft washers, remove washers and bearing and examine clutch push rod and adjusting screw end for excessive wear. Order your parts requirements using part numbers shown below. Credit for damaged parts will be given following normal warranty procedures.
