ALTERNATOR WITH AUTOMATIC ADVANCE RETARD / SS, SX-175, 250

1976 and later SS/SX-175, 250 motorcycles built in Italy, starting with the following vehicle identification numbers, are equipped with automatic ignition advance/retard feature to improve starting and to eliminate kickstarter lever kickback.

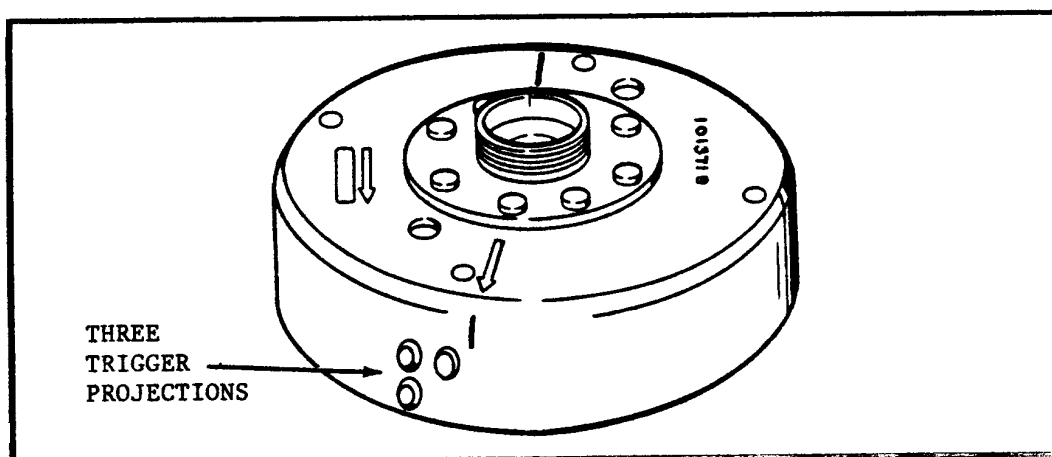
ALTERNATOR FLYWHEEL ROTOR - ILLUSTRATION A

Also, some York produced 1976 motorcycles incorporate this feature. To aid in identifying these motorcycles, the flywheel rotor has three trigger projections on the outer diameter instead of two as on previous models. See illustration A.

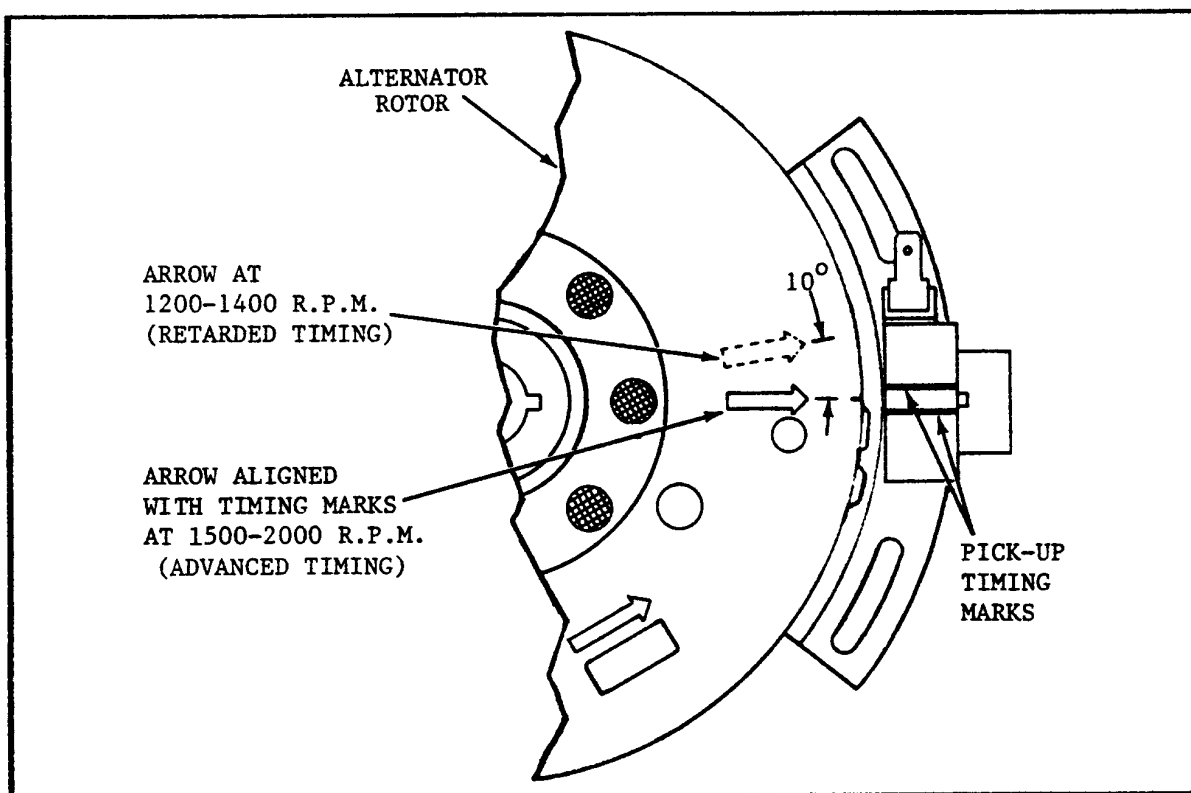
ROTOR AND PICK-UP TIMING MARKS - ILLUSTRATION B

2. Connect timing light and start engine. With engine running at a slow idle (1200-1400 rpm), timing arrow on rotor should not be aligned with timing marks on pick-up, but rotated about 10 degrees in a counterclockwise direction. With gradual acceleration to 1500-2500 rpm, arrow on rotor should instantly align between pick-up timing marks. See illustration B. If speed is increased to 7500 rpm, the arrow should remain in position without any variation.

With engine running at idle or maximum rpm no change in advance is observed with strobe timing light (rotor arrow is always aligned between pick up marks). Engine will run satisfactorily, but engine kickback may occur during starting.

With engine at idle, operation is erratic and with strobe timing light, the rotor arrow oscillates between advance position and retard position.

Engine tends to run hot, has loss of power, and detonates when accelerating or running at part throttle under heavy loads. The higher the speed at which the timing advances, the more serious these problems become. Under certain conditions the engine may never reach 21 degrees advanced timing.

When the advance point is found abnormal per previous items 1, 2 and 3, we suggest that you first substitute a new module. The latest type module is available under part No. 29970-74PA and is identified with the code number 27999 or a red paint dot on the outside, and has been tested for advance/retard operation

If after testing with several new modules, the trip rate remains abnormal, install the latest rotor identified with suppliers stamped number 101371B. The new rotor only is available under Harley-Davidson part No. 24009-78P.

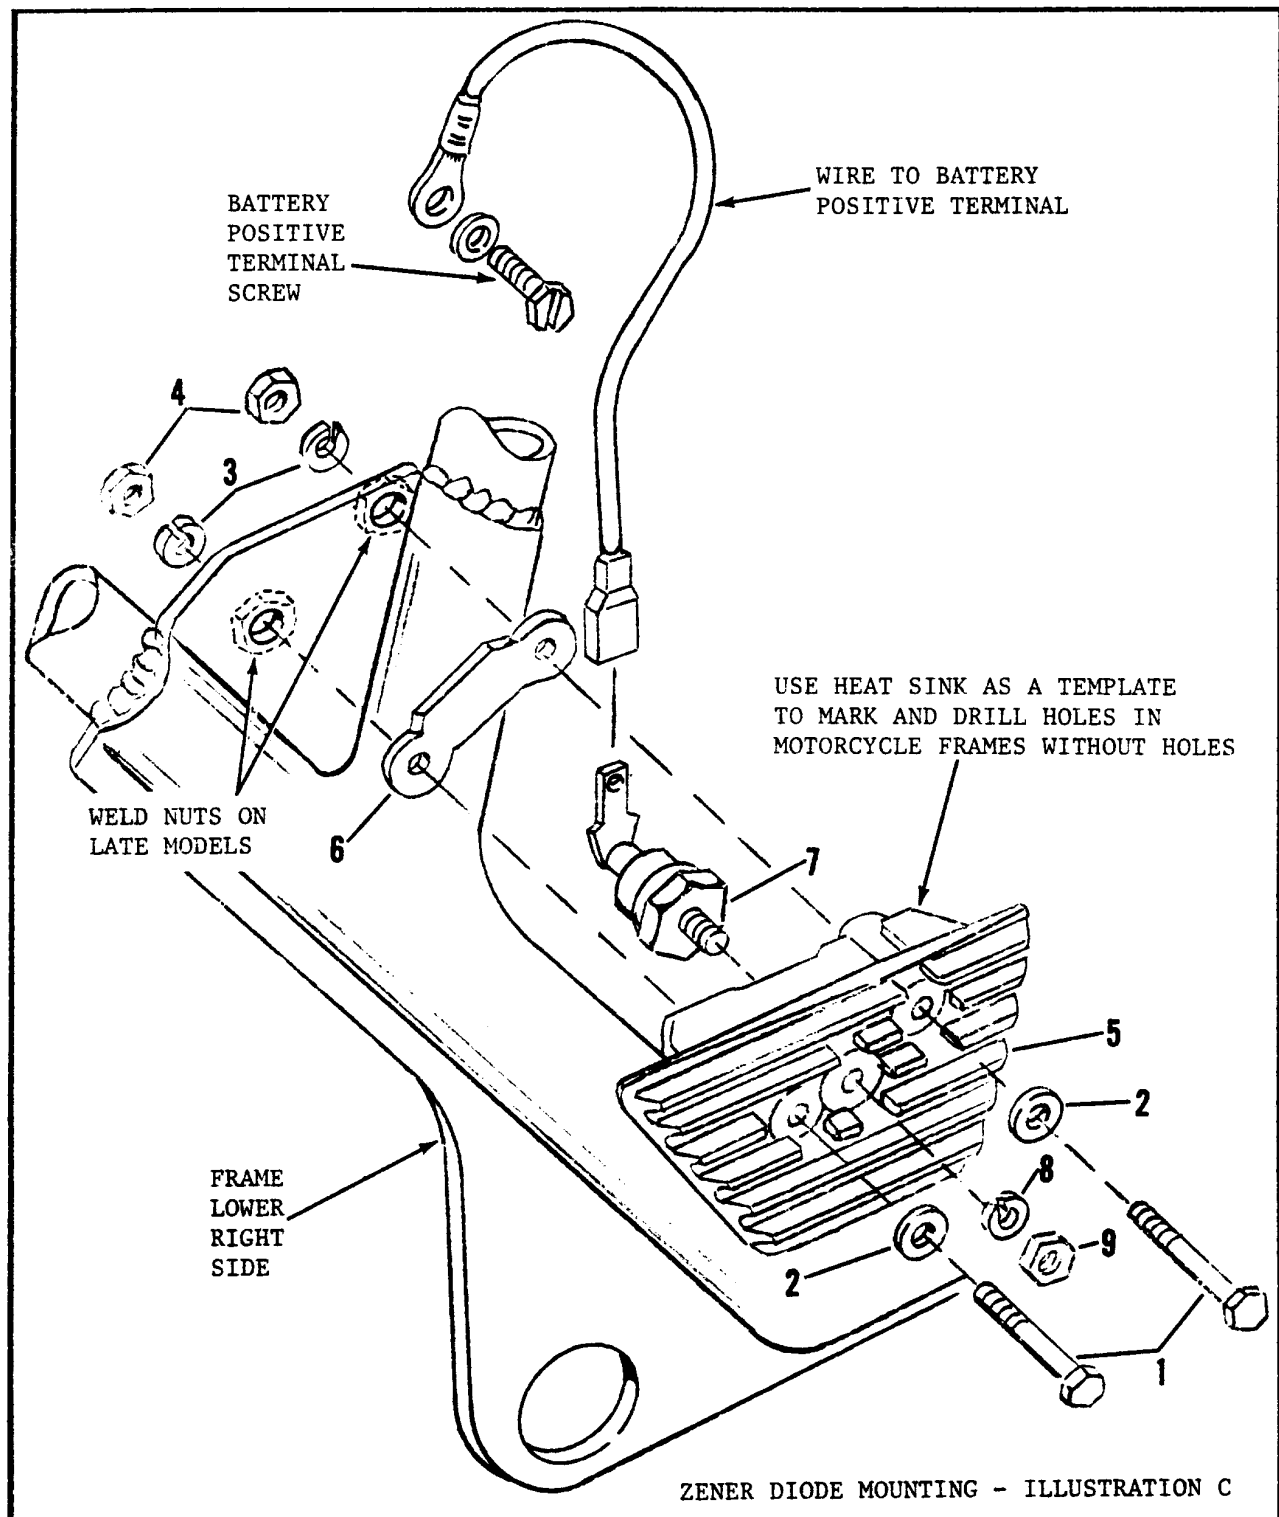
The 1976 and later models involved may or may not have a zener diode already installed in one of the two locations. One location is underneath the front fork tube lower bracket below the head lamp. The other location is on the frame bracket just outside the battery on the right side of the motorcycle. If the new rotor is used and there is no zener diode, one should be installed on the frame using the following parts: (See illustration C)

The heat sink and diode assembly should be mounted on the frame using the bolt holes provided in the bracket located just outside the battery on the right side of the motorcycle. Connect the wire to the diode terminal and the battery positive (+) terminal.
