SERVICE BULLETIN

M-839

October 2, 1981

BATTERY CABLE ROUTING — 1982 XL MODELS

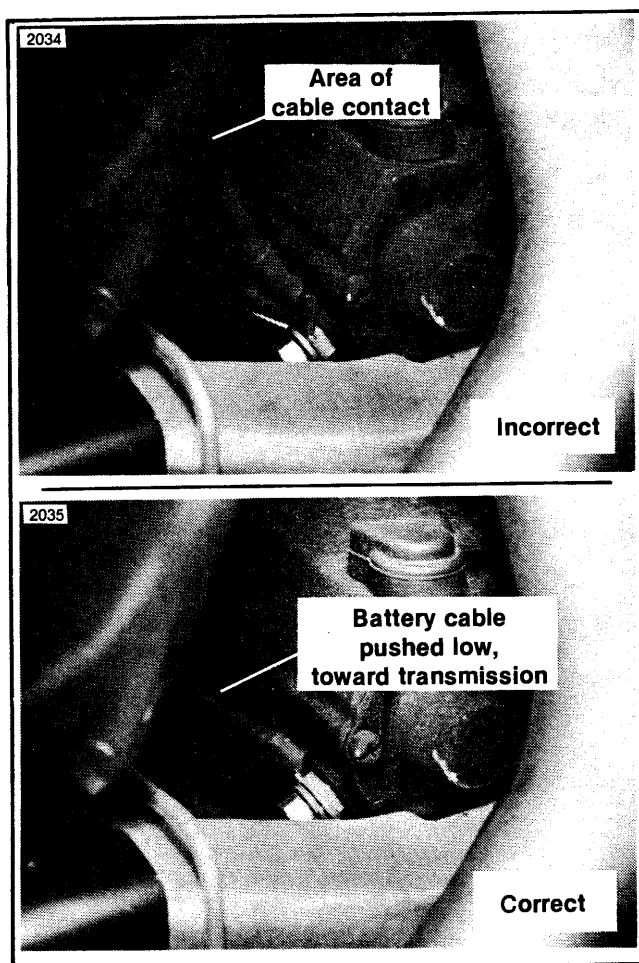
Figure 1. Connection to Starter

The positive battery cable on some 1982 vehicles, prior to VIN 1HD1CAH15CY111159, may contact the leading edge of the oil tank. This surface could cut the insulation, causing a short circuit.

See Figure 1 and 2. Inspect all vehicles during predelivery and setup. Reroute cable, if required, per illustrations below.
