SERVICE BULLETIN

M-886

April 6, 1984

XL/XR SPROCKET NUT

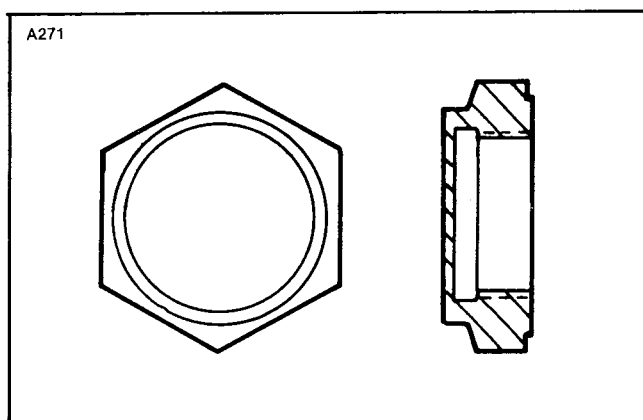
Figure 1. Mainshaft Sprocket Nut

A service replacement mainshaft sprocket nut, Part No. 35049-71, has been developed to prevent transmission oil leakage from the sprocket splines on 1971 through early 1984 models.

The new sprocket nut, Figure 1, encloses the end of the mainshaft and provides a metal-to-metal seal between the sprocket, lockwasher and nut when tightened to 35-65 ft-lbs torque.
