# SERVICE BULLETIN

M-1088

## 2000 MODEL YEAR XL VOLTAGE REGULATOR

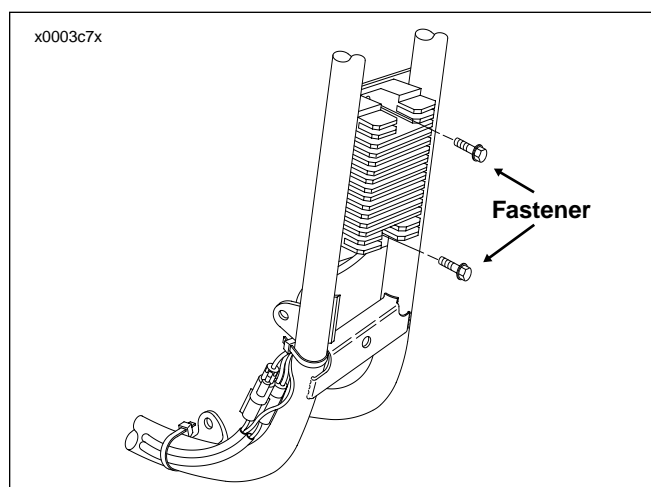
Figure 1. Voltage Regulator

It has come to our attention that a grounding issue may exist with the voltage regulator on the Model Year 2000 XL Motorcycles. Voltage regulators are self grounding from the face of the regulator to the threads in the frame mount area. It has been observed the fasteners holding the voltage regulator were not digging completely through the paint on the frame mount area, hence not making a good ground contact with the regulator.

1. See Figure 1. Back fasteners out one full turn.

2. Retorque fasteners to 70-80 in-lbs (7.9-9.0 Nm).

*This action removes the paint from underneath the fastener head area and allows metal to metal contact for proper ground.*
