# SERVICE BULLETIN

M-1103

## REVISED TRANSMISSION VENT HOSE ROUTING FOR 2000 MODEL SPORTSTERS

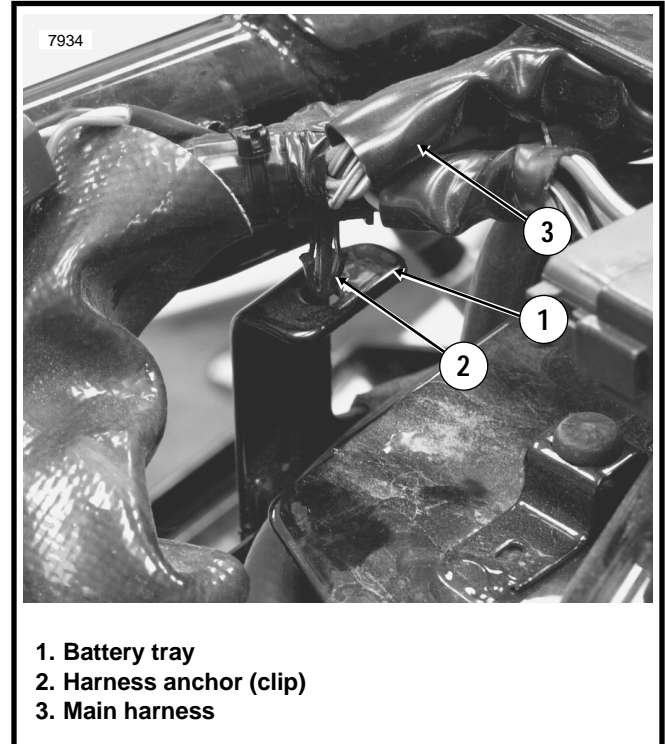
Figure 1. Releasing Harness Anchor

1. Battery tray
2. Harness anchor (clip)
3. Main harness

2. On XL-1200S only, remove ignition module bracket and move bracket and module aside. (This will allow access to T-stud clip attaching vent hose on inboard side of oil tank.)
3. Gently pull left side cover so barbs on cover are pulled out of rubber grommets.
4. At rear of battery tray, unlatch and disconnect harness connector on bank angle sensor. (See Figure 4. Bank angle sensor is identified.)
5. See Figure 1. Gently compress barbs of harness anchor (2) with a needle nose pliers and pull anchor from hole in battery tray.
6. See Figure 2. Remove battery tray and battery pad.

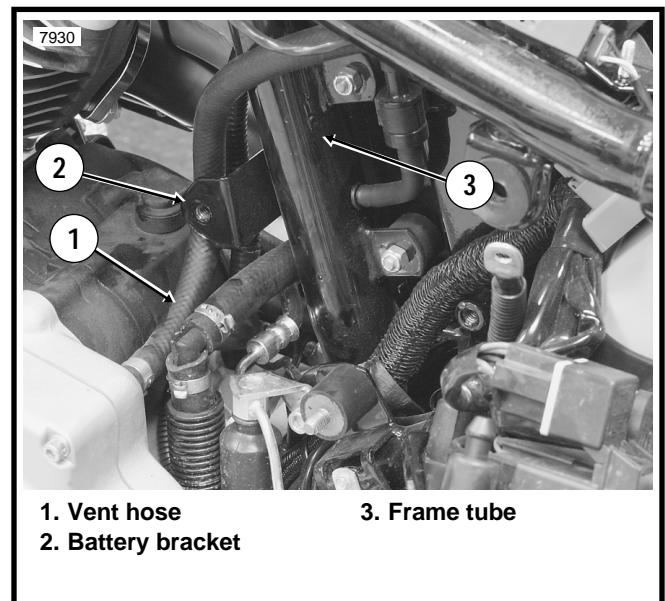
Figure 2. Battery Tray Removed

1. Vent hose
2. Battery bracket
3. Frame tube

7. See Figure 3. Remove T-stud clip attaching vent hose to inboard side of oil tank. (Skip this step if clip was removed in step 2 above.)
8. See Figure 2. Reroute vent hose (1) behind front battery bracket (2), up and outboard of frame tube (3).
9. See Figure 4. Install battery tray and connect harness connector (3) on bank angle sensor.
10. See Figure 4. Locate positive battery cable (1) between vent hose and oil feed/drain hose. Loosely install cable strap, Part No. 10006, (2) to locate vent hose on battery tray as shown.
11. See Figure 3. From battery tray route vent hose to inboard side of oil tank and secure with T-stud clip.
12. See Figure 1. Install harness anchor (2) in battery tray hole.
13. Refer to Section 7 of the XLH Service Manual, install battery and seat.

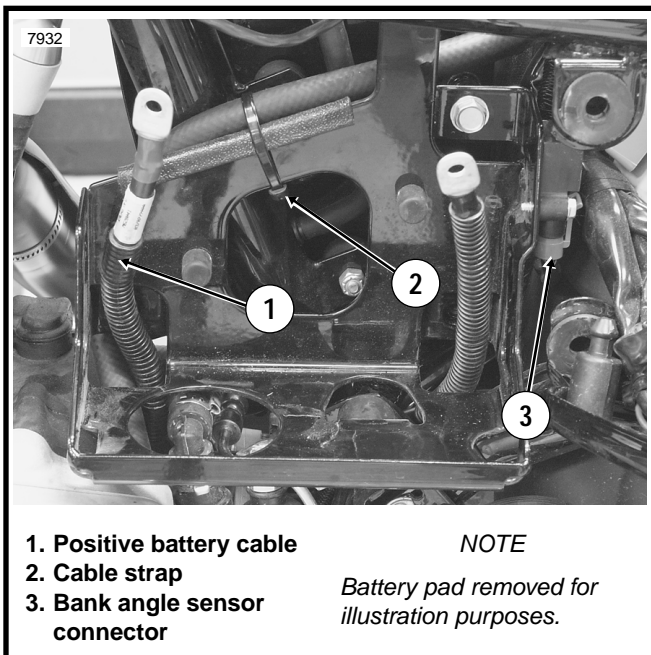
**Figure 4. Vent Hose Attached To Battery Tray**

1. Positive battery cable
2. Cable strap
3. Bank angle sensor connector

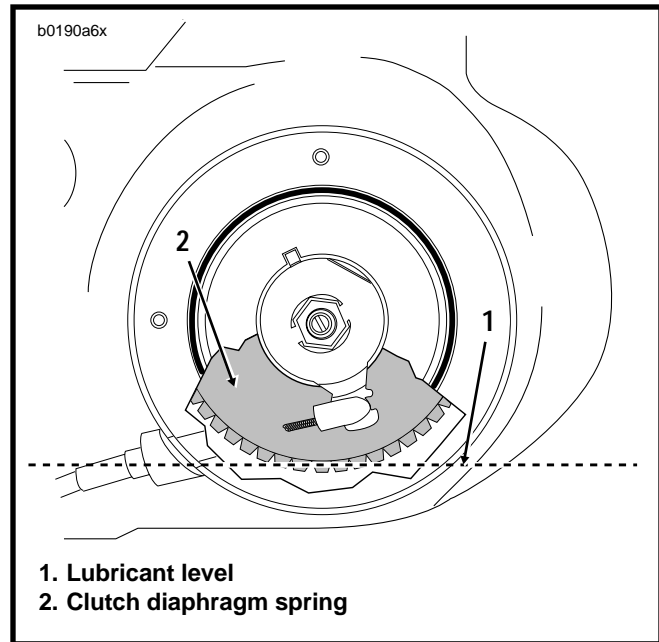
**Figure 5. Lubricant Level With Motorcycle Upright**

1. Lubricant level
2. Clutch diaphragm spring

14. See Figure 5. Refer to Section 6 of the XLH Service Manual and remove clutch inspection cover. Check that transmission/chaincase is not overfilled. Drain to proper level if necessary.

**When performing regular scheduled transmission fluid changes, only fill to the level shown in Figure 5. Do not simply add 32 oz. as there may be fluid retained in transmission cavity which could then cause an overfilled condition.**
