SERVICE BULLETIN

M-1176

October 10, 2005

ADVANCED AUDIO SYSTEM SOFTWARE UPDATE

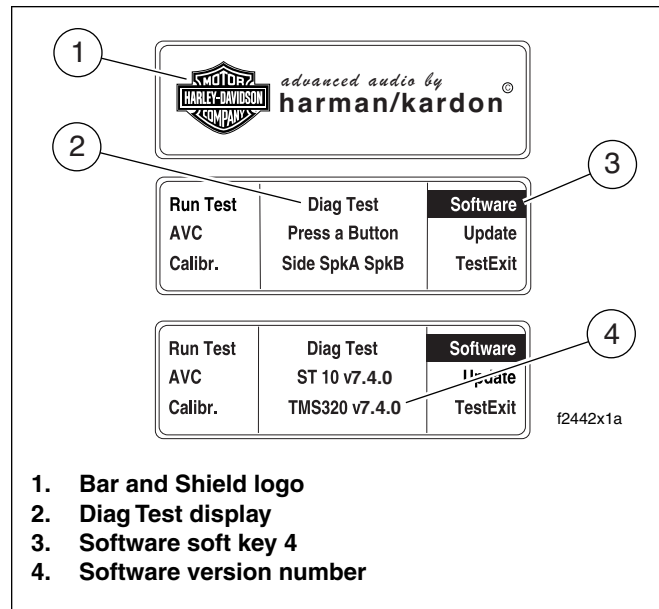
Figure 1. Identify Software Version Number

1. Turn the ignition/headlamp key switch to OFF.
2. Simultaneously press and hold any two soft keys (1, 2, 3, 4, 5, or 6).
3. Turn the ignition/headlamp key switch to ACCESS.
4. See Figure 1. Continue to hold the two soft keys while the Harley-Davidson Bar and Shield logo (1) is displayed. The display will cycle to Diag Test (2).
5. Press the Software (3) or number 4 soft key to display the software version number (4).
 - a. If the software version number is lower than 7.8.0, **Update Receiver Software** with the v7.8.0 update CD.
 - b. Receivers with v7.8.0 or higher will not need to be updated.
