Bulletin number M1450 must be entered into the comments section of the claim.

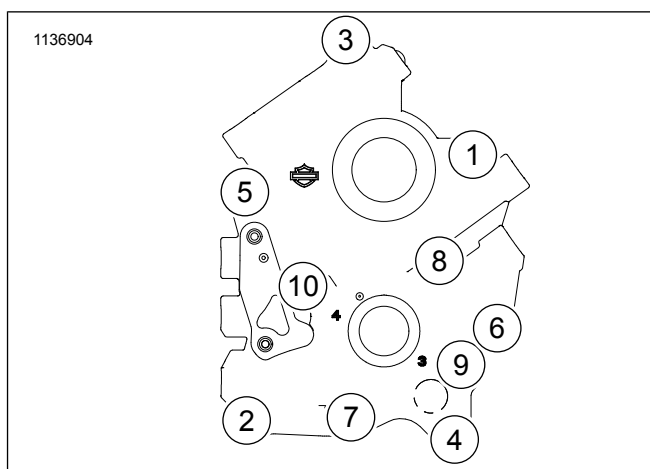
Figure 1. Cam Support Plate Tightening Sequence

8. The condition is likely caused by sumping.
 - a. Verify cylinder and piston integrity (scuffing, scoring, oil rings present).
 - b. Verify that connecting rod bearings roll free and smooth. Connecting rod bearings that require more than light force to separate may require additional service.

- c. A reduction in piston jet assembly screw torque is expected after operation due to gasket compression. Unless piston jet assembly is visibly loose, the piston jet assembly gasket is mis-installed or the gasket or a screw is missing, the piston jet assembly joint will not cause sumping. Tighten piston jet assembly.
Torque: 3.1–3.7 N·m (27–33 **in-lbs**)

1. Install cam support plate. See the service manual.
2. Refer to Figure 1. Follow modified tightening sequence.
Torque: 10.4–12.7 N·m (92–112 **in-lbs**)
 - a. Tighten screws 1-6.
 - b. Rotate crankshaft 360°.
 - c. Tighten screws 7-10.
