SERVICE BULLETIN

M1482

2019-04-16

M1482: RECALL 0173 - SECONDARY ACTUATOR ASSEMBLY REPLACEMENT

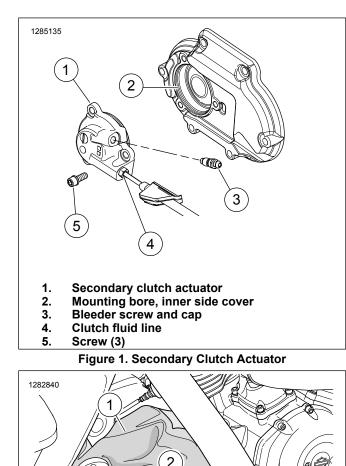
- A small amount of transmission lubricant may drain when secondary clutch actuator is removed.
- Do not disconnect clutch fluid line (4).
- 2. See Figure 1. Remove secondary clutch actuator (1) from inner side cover mounting bore (2).
 - a. Remove screws (5) and secondary clutch actuator.
- 3. See Figure 2. Place **clean** lint free shop towel over transmission inner side cover at secondary actuator bore.

- 2. See Figure 1. Install secondary clutch actuator (1).
 - a. Lubricate mounting bore (2) in the inner side cover with a film of transmission fluid.
 - b. Install secondary clutch actuator (1) and screws (5).
 - c. See Figure 6. Draw screws down evenly to prevent binding and possible breakage of mounting ears. Tighten in sequence as shown.

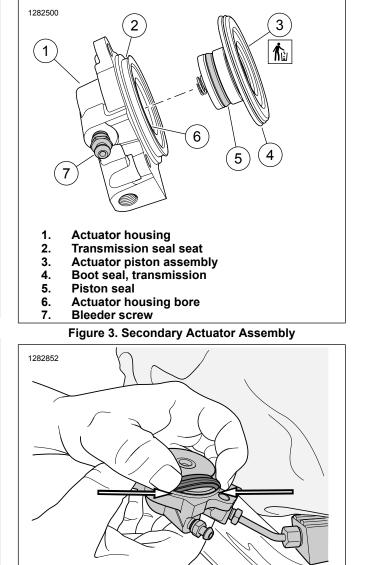
Figure 4. Pinching Actuator Transmission Seal Boot

To avoid scratching the transmission seal seat (2), **do not** use any tools to remove the transmission seal boot (4) from actuator housing (1).

- 1. See Figure 3. Remove the actuator piston assembly (3).
 - a. See Figure 4. Pinch the actuator transmission seal boot (4).
 - b. See Figure 3. Remove the transmission seal boot from the transmission seal seat (2).
 - c. Remove piston assembly from actuator housing (1).
- 2. Hold old actuator piston assembly per Return Parts.
