SERVICE BULLETIN

M1514 2021-02-11

M1514: 2020 SOFTAIL - CLUTCH RAMP RUNNING CHANGE

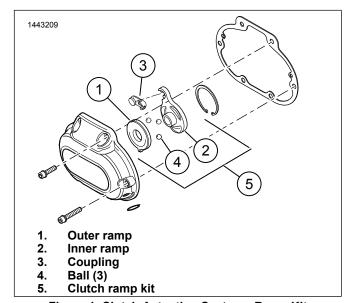
Figure 1. Clutch Actuation System - Ramp Kit

To inform dealers of a running change to the inner and outer ramp of the clutch actuation system in all 2020 Softails built on and after March 15, 2020.

See Figure 1. Harley-Davidson is creating a kit (Part No. 37000376) for this change.
