# SERVICE BULLETIN

M1533 2021-06-29

## M1533: 2021 PAN AMERICA STARTER WIRE

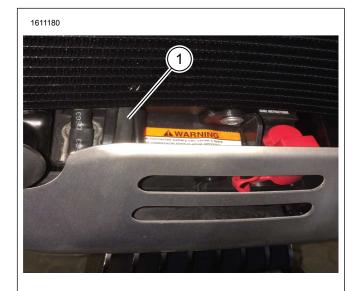
Figure 1. Correct Cable Routing

See Figure 1. Visually inspect the cable and insure that it is properly routed in the battery bracket channel.

1. Cable Seated in Battery Bracket Channel

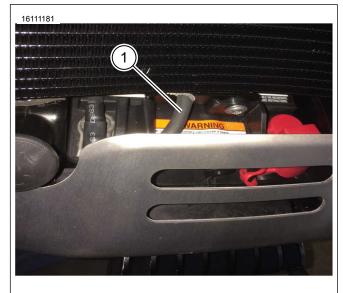
Figure 2. Incorrect Cable Routing

This bulletin is to inform dealers of a possible incorrect starter wire routing. The dealer will need to inspect and correct any wire routing issues on MY21 Pan America models.

1. Cable NOT Seated in Battery Bracket Channel

See Figure 2. If cable is not in battery channel, reposition the cable by hand into the battery bracket channel.

Inspect the cable for any possible chaffing or damage. If cable is damaged, replace cable and follow normal warranty procedure.
