SERVICE BULLETIN

M1536 2021-08-27

M1536: PAN AMERICA BCM UPDATE

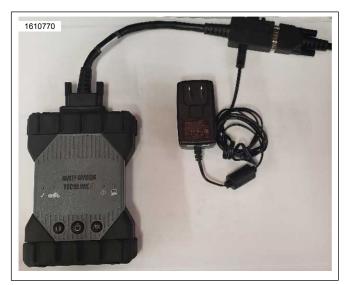
Figure 1. External Power Adapter

See Figure 1. External power adapter must be plugged into Techlink 3 (TL-3) for BCM reflash procedure to prevent unrecoverable lockups.
