# SERVICE BULLETIN

M1540 2021-10-21

## M1540: 2021 PAN AMERICA ECM UPDATE

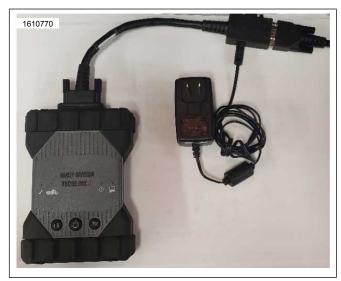
Figure 1. External Power Adapter

See Figure 1. External power adapter must be plugged into Techlink 3 (TL-3) for ECM reflash procedure to prevent unrecoverable lockups.
