SERVICE BULLETIN

M1543 2021-12-13

M1543: RECALL 0178 - 2021 PAN AMERICA SEAT BASE

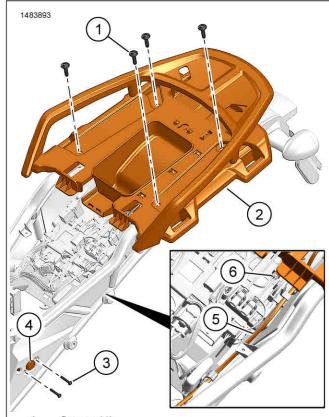
Figure 1. Seat Base Assembly

- 1. Screw (4)
- 2. Seat base assembly handhold
- 3. Screw (2)
- 4. Lock cylinder
- 5. Seat lock cable
- 6. Tail lamp connector

- 1. Remove seat. See service manual.
- 2. See Figure 1. Remove passenger handhold assembly.
 - Remove screws (1).
 - b. Remove screws (3).
 - c. Disconnect tail lamp connector (6).
 - d. Remove seat base assembly.
- 3. See Figure 2. Remove tail lamp.
 - a. Remove screws (1).
 - Remove tail lamp.
- 4. See Figure 3. Remove passenger handhold.
 - Remove screws (5).
 - Remove Original Equipment (OE) passenger handhold (1).

- 1. See Figure 3. Install passenger handhold.
 - a. Install new passenger handhold (1).
 - Install screws (5). Tighten.
 Torque: 7–8.5 N·m (62–75 in-lbs) Handhold screw
- 2. See Figure 2. Install tail lamp.
 - a. Install tail lamp.
 - Install screws (1). Tighten.
 Torque: 7–9 N·m (62–80 in-lbs) Tail lamp screw
- See Figure 1. Install passenger handhold assembly.
 - a. Install lock cylinder (4).
 - Install screws (3). Tighten.
 Torque: 1.3–1.7 N·m (12–15 in-lbs) Seat lock cylinder screw
 - c. Connect tail lamp connector (6).
 - d. Install seat base assembly (2).
 - e. Install screws (1). Tighten.

Torque: 22.5–27.7 N·m (17–20 ft-lbs) Seat handhold base screw
- Install seat. See service manual.

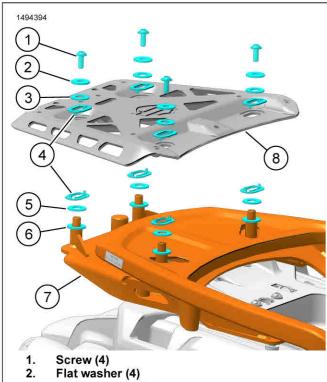
Figure 4. Top Plate Hardware

- 3. Plastic washer (4)
- 4. Plastic slide (4)
- 5. Plastic washer (4)
- 6. Custom washer (4)
- 7. Mounting bracket
- 8. Top plate

- Remove top case, if installed.
- Remove seat. See service manual.
- See Figure 4. Remove four screws (1), flat washers (2) and plastic washers (3).
- 4. Remove top plate (8).
- 5. See Figure 5. Remove screws (4).
- See Figure 6. Remove screws (1).
- Remove OE passenger handhold (2).
- See Figure 6. Install new passenger handhold.
 - a. Loosely install screws (1) on both sides.
 - See Figure 5. Install handhold base to handhold screws (4).
 - c. Tighten all screws.

- 9. See Figure 4. Install top plate.
 - Install custom washers (6), plastic washers (5) and plastic slides (4) onto mounting bracket (7).
 - b. Install top plate (8).

Make sure plastic slides (4) are in position on both sides of the top plate before tightening screws (1).

- Install plastic slides (4), plastic washers (3), flat washers (2) and screws (1).
- Tighten screws (1).
 Torque: 9.5 N·m (84 in-lbs) Top plate screw
- 10. Install seat. See service manual.
