SERVICE BULLETIN

M1544 2022-01-03

M1544: 2021 TOURING AND TRIKE MECHANICAL CLUTCH CABLE

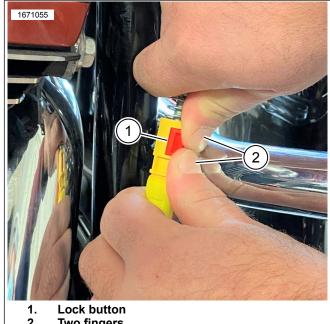
Figure 1. Wrong Procedure

- 1. See Figure 1. Do not use two hands to push-in lock button.
- 2. Do not use any tools to push-in lock button.

Two fingers

- See Figure 2. Use only one finger to push-in lock button.
- Only minimal effort is required to push-in lock button.
- If excessive force is being used, stop and take a closer 3. look at the clutch cable/housing assembly.
- Review procedures and pictures below to make sure button is not being impeded.

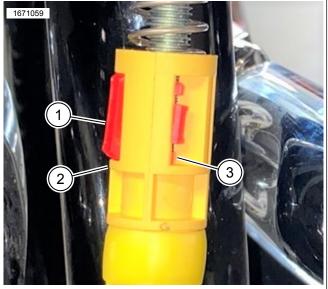
Figure 5. Improperly Installed Button

Improperly installed lock button with tabs misaligned, tabs not properly engaged or upper clutch cable interfering with the lock button, is a sign of incorrect internal adjustment. See the service manual for clutch adjustment.

- 1. See Figure 3. Lock button tabs are not fully engaged (1) because the end of the upper clutch cable (2) is interfering with securing the button.
- See Figure 4. The tabs on lock button tabs are not fully secured.
 - Lock button tabs partially engaged (1). a.
 - b. Lock button tab not fully engaged (2).
- See Figure 5. A misaligned lock button (1, 3) is a sign of an incorrect installation.

- 1. Misaligned lock button
- 2. Clutch cable body
- Misaligned lock button

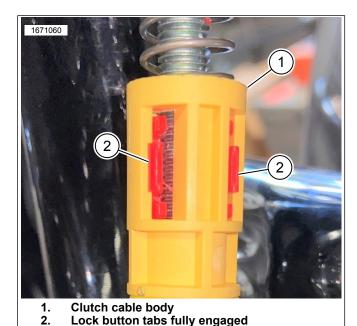
Figure 6. Correctly Installed Button

- 1. See Figure 6. Lock button tabs are fully engaged (2) to clutch cable body (1).
- 2. See Figure 7. A properly aligned lock button (1) should be semi-flush with the rest of the cable clutch assembly.
- 3. The lock button tabs should be fully engaged (2) to the body.
- 4. See Figure 8. Make sure the lock button (4) is installed between the ends of upper clutch cable (1, 3).

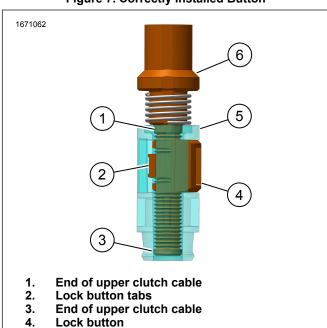
Figure 8. Proper Button Engagement

Clutch cable body Upper clutch cable
