# SERVICE BULLETIN

M1559 2022-08-02

## M1559: REVOLUTION MAX ECM UPDATE

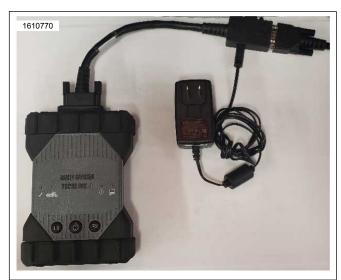
Figure 1. External Power Adapter

See Figure 1. External power adapter must be plugged into Techlink 3 (TL-3) for ECM reflash procedure to prevent unrecoverable lockups.

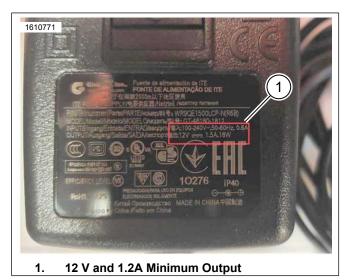
Figure 2. 12 V and 1.2A Output

- See Figure 2. The external power adapter must have an output of at least 12 V and 1.2 A. This includes the power adapter included with the TL-3 or the adapter for the DT II.
- The vehicle battery should be fully charged prior doing the software update.
- Have a battery tender connected to the battery while performing software update.
