# SERVICE BULLETIN

M1566 2022-10-14

# M1566: RECALL 0179 - RH975 HANDLEBAR

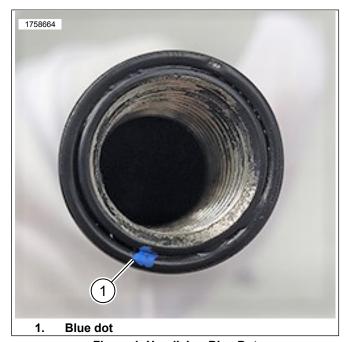
Figure 1. Handlebar Blue Dot

See Figure 1. If dealers have old stock, inspect the part to ensure a small blue paint dot is present on the end of the handlebar. If no dot is present then replace by following the credit procedures in Table 9 or Table 10.
