## SAFETY RECALL CODE 0807 - 1997/1998 FRONT BRAKE ROTOR DRIVE PINS

### GENERAL

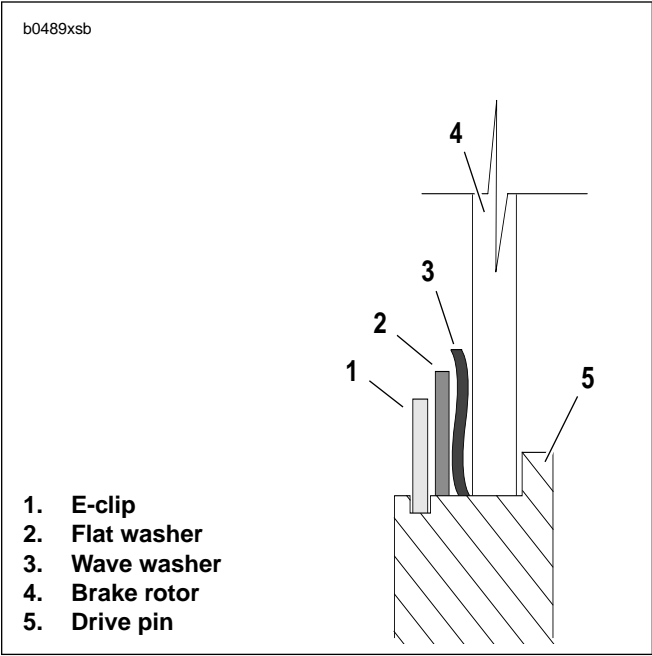
Figure 1. Drive Pin Assembly

Buell has determined that the drive pin(s) used on the front brake rotor could move out of position and come in contact with the front brake caliper. This condition could prevent the front wheel from rotating. This could occur without prior warning.

2. See [Figure 1](#). Remove existing drive pin assemblies two at a time.
  - a. Gently pry E-clip (1) away from drive pin (5).
  - b. Completely remove E-clip using a thin bladed screwdriver. Discard E-clip.
  - c. Remove and discard flat washer (2), wave washer (3) and drive pin (5).
3. See [Figure 2](#). Install **new** drive pin hardware through rotor (5) and carrier (8).
  - a. Place drive pin (6) between rotor and carrier. Shoulder on drive pin faces away from wheel hub.
  - b. Insert bolt (7) through drive pin (6).
  - c. Install wave washer (4) on back side of rotor.
  - d. Install flat washer (3).
  - e. Install drive pin flat washer (2).
