SERVICE BULLETIN

B-050

February 14, 2003

CRITICAL DRIVE BELT HANDLING PROCEDURES

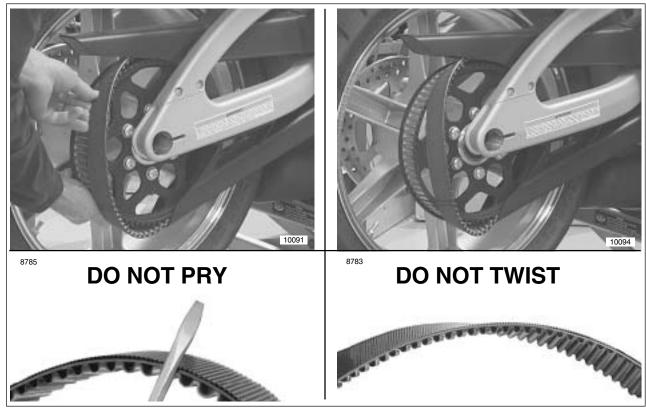
Improper belt handling procedures affect all Buell motorcycles. Detailed analysis of drive belts from 2003 XB models returned under warranty has shown a trend in failures due to improper belt handling during routine servicing.

Do not leave the upper and lower belt guards and the idler pulley attached to the vehicle during the removal of the rear wheel. Follow complete service manual procedures.

Figure 1. Improper Handling of Drive Belt During Rear Wheel Removal

Follow complete procedures for removing belt guards and idler pulley on 2003 models XB9R and XB9S. These procedures can be found in service manuals Part No. 99493-03Y and Part No. 99490-03Y.
