SAFETY RECALL CODE 0826 - SIDESTAND LEG FOR 2003 LIGHTNING XB9SL

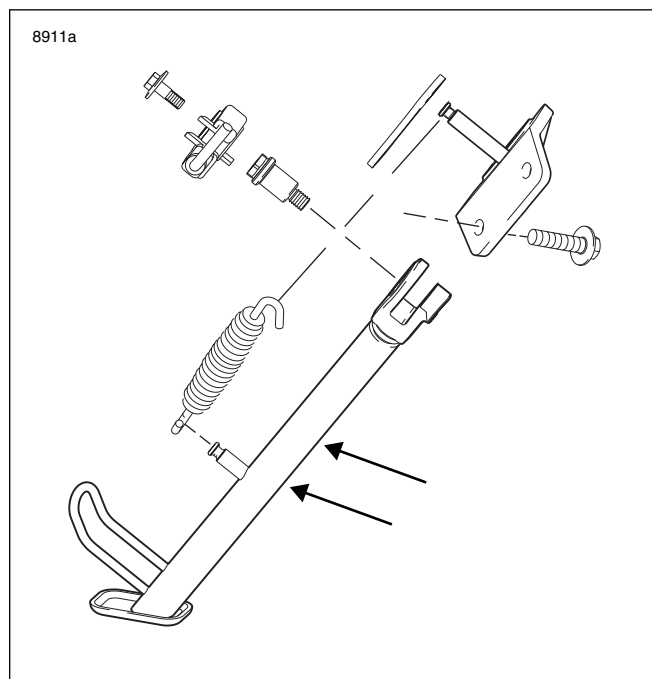
As recently advised, Buell Motorcycle Company has decided that there is a safety defect with the sidestand legs on certain 2003 XB9SL motorcycles which causes them to have the potential to bend or break without notice, thereby allowing the motorcycle to fall and potentially cause an injury.

**Figure 1. Sidestand Assembly with Sidestand Leg
(Part No. 94218Y)**

See [Figure 1](#). The correct replacement sidestand for the purpose of this bulletin is Part No. 94218Y.

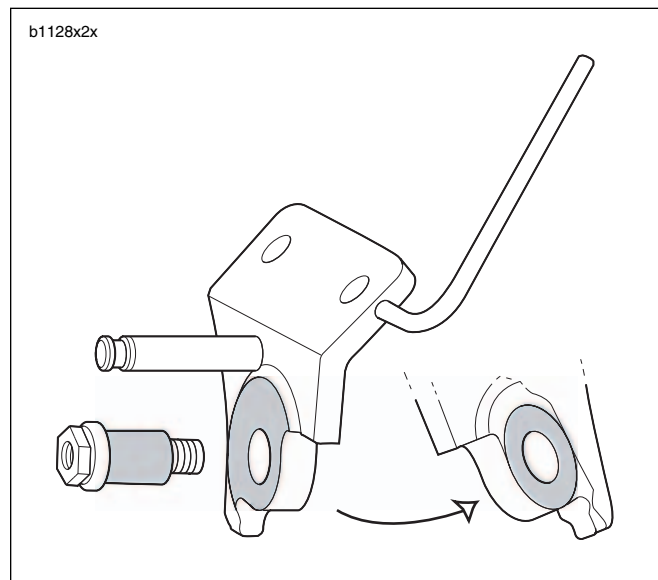
Figure 3. Lubricating Points (Shaded Areas)

1. Install sidestand leg (1).
 - a. See [Figure 3](#). Lubricate sidestand pivot bolt and mating portions on sidestand bracket with WHEEL BEARING GREASE (Part No. 99855-89).
 - b. See [Figure 4](#). Apply LOCTITE 272 (Red) to threaded area (clevis) of sidestand leg.

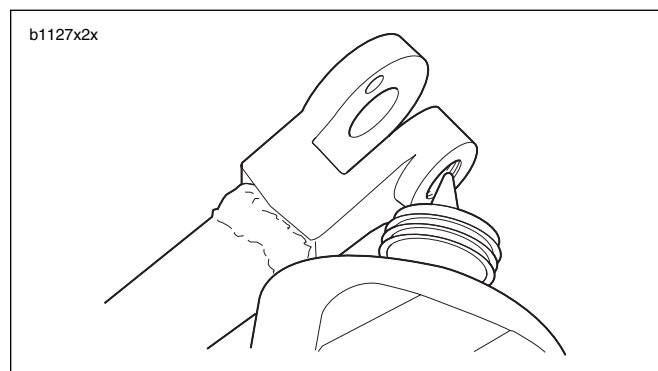
Figure 4. Threaded Area for Loctite Application

Applying LOCTITE to threaded area of clevis on sidestand leg, instead of threads on the pivot bolt, will eliminate build-up between clevis and sidestand bracket which can interfere with the applied lubricant.
