SERVICE BULLETIN

B-060

May 02, 2005

SAFETY RECALL CODE 0830 - SIDESTAND PIVOT BOLT FOR 2005 FIREBOLT XB12R AND LIGHTNING XB12S, XB9SX

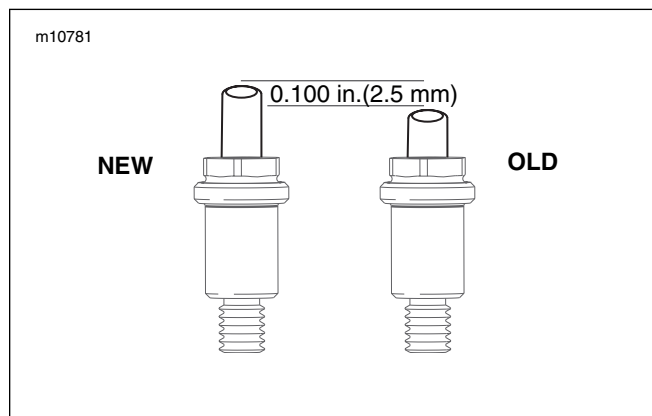
Figure 1. Correct Pivot Bolt with Springplate Pin

See Figure 1. Correcting the potential safety defect requires replacement of the sidestand pivot bolt, Part No. L0174.1AA. The replacement pivot bolt, Part No. L0174.1AAB, is 0.100 in. (2.5 mm) longer in the spring plate pin area and has a gold hue plating. **The recall kit Part No. is 94394Y.**
