MiscRes: Factory Recalls

Factory Recalls

This is a complete Factory Safety Defect Recalls (regarding Sportsters) from 1967-1979 of the MoCo's Motorcycle Safety Defect Recall Campaign. More will be added when found.

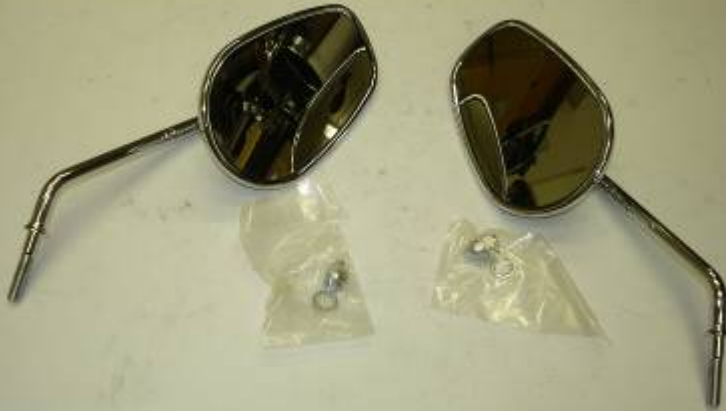
Mirror Kit 94190:

Mirror Kit (94190) for HD Safety Recall Code 0108
regarding 2002 XL1200C motorcycles

Right side mirror (91846-03), Left side mirror (91848-03)

| Year Model | Recall # | Recall Date | TSB # | Subject | Sportster VIN Range |
|---|---|---|---|---|---|
| <p>For Any XL1200C assembled/shipped from the Kansas City, Missouri plant equipped long stemmed mirrors (left 91902-88A and right 91904-88A). Certain 2002 model year 1200 Custom Sportster motorcycles have a condition whereby the left side mirror stem may fracture. This may allow the mirror to fall, possibly without warning, and present an unreasonable risk of accident, injury or death. In the interest of motor vehicle safety and customer satisfaction, HD elected to initiate a voluntary recall to replace both mirrors on all affected motorcycles with current production parts. See TSB M-1136 for dealer action required to perform the recall service.</p> <p>Click Here to go to the TSB page in the Sportsterpedia.</p> <p>Scroll down to bulletin M-1136, click on the "Y" in the chart to download the service bulletin.</p> | | | | | |

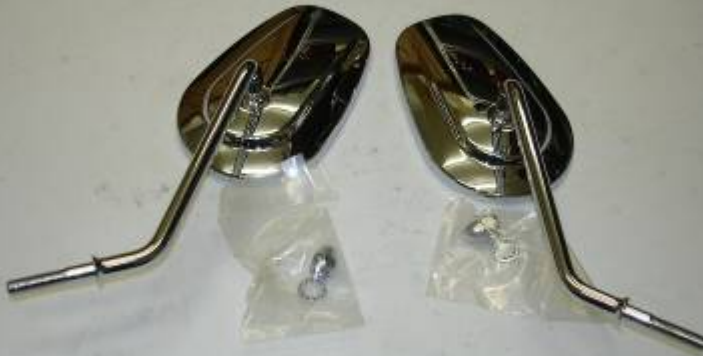
Mirror Kit (94190) for HD Safety Recall Code 0108
regarding 2002 XL1200C motorcycles

Right side mirror (91846-03), Left side mirror (91848-03)

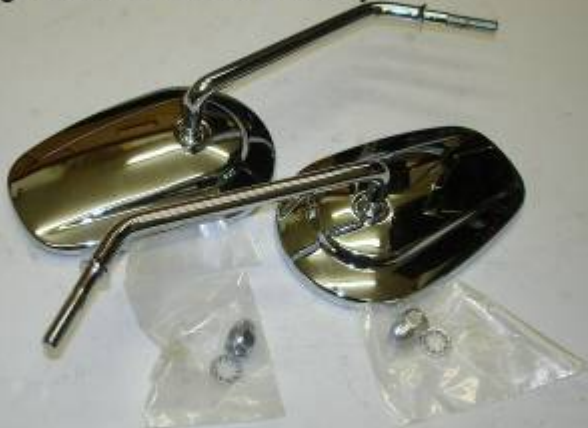
Mirror Kit (94190) for HD Safety Recall Code 0108
regarding 2002 XL1200C motorcycles

Right side mirror (91846-03), Left side mirror (91848-03)
