"900 Tranny Fix" - How to Fix a Cracked Countershaft Bearing Boss

900 TRANNY FIX

How To Fix A Cracked Countershaft Bearing Boss

Text and photos by Tom Hurd

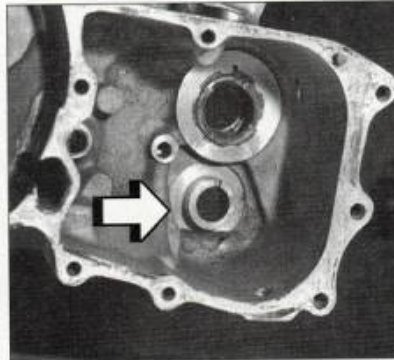
Unless your nickname is "Hole Shot Harry," this section of the case should be fine on a stock horsepower/torque engine. But with a mill that has more power and/or there are a few hole shots in the engine's past, there's a chance this bearing boss is cracked. Once the boss cracks enough, the bearing fails, the countershaft cocks, and in a split second your transmission is garbage and parts of your case are on the street mixed with tranny oil.

This small boss (see arrow) is the weak link in the drive line. All 1973 and later Ironheads have more than twice the wall thickness of this boss.
