# REF: Electrical System

## Ironhead Wiring Mishaps and Meltdowns

## Broken Horn Bracket

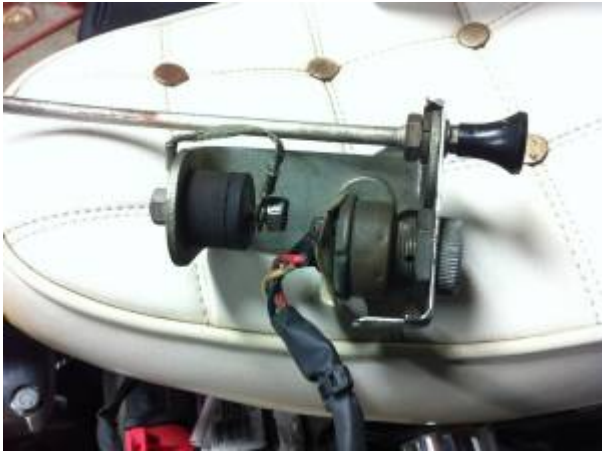
See the 'before' pic of the horn / switch brackets below (taken  $\approx$  8 months prior to my catastrophic event).

**Note the exposed screws on the back of the ignition switch.**

Before pic. Note the relative pristine condition of the horn mounting bracket, p/n 69129-72. <sup>2)</sup>

The ends of the ignition switch wires were heat-shrink'd immediately after this pic was taken.

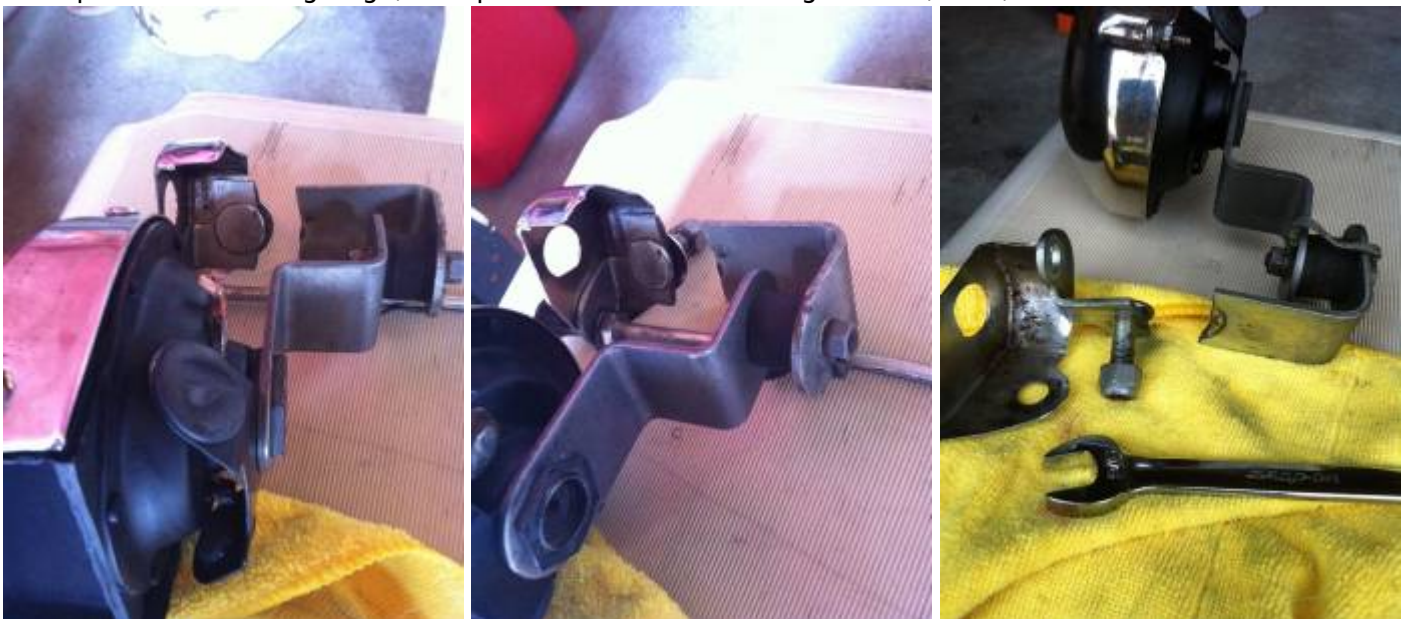
Should the horn bracket break, the horn will (most likely) swing down & rest on the back of the ignition switch for awhile, shorting the terminals.

The subsequent dead short heats up the wires, melting them and triggers the carnage shown below.

This happened to my 74 XLH and all initially started by a broken horn bracket:

After pics. Back in the garage, with pics of the horn mounting bracket, et al, after removal. <sup>3)</sup>

For the fix, I added a reinforcement to the horn bracket & TIG welded it up, replaced all those wires, & added my own fuse wire.

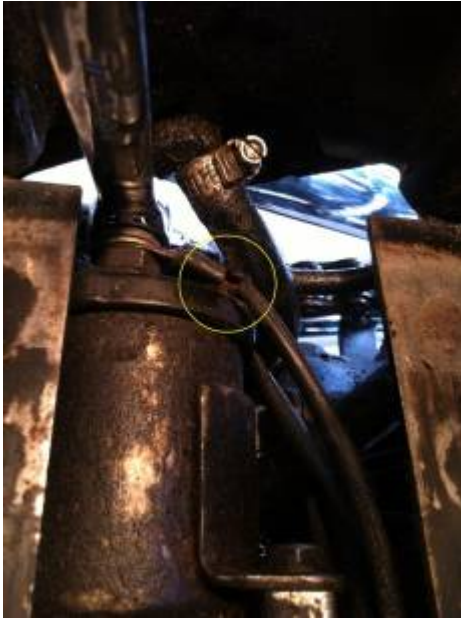
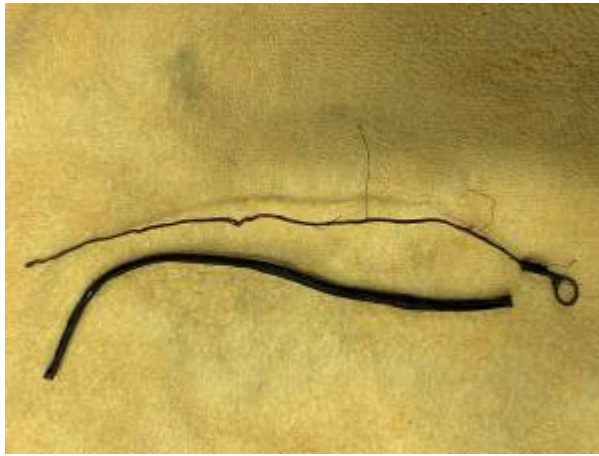
First pic below is the RED wire from the solenoid to voltage regulator, note the insulation (on what was the RED wire) has evaporated.

On a '74 XLH, this wire is the main feed that runs from the solenoid to the Delco voltage regulator. I fully expected this wire to be burnt thru. It wasn't. Another RED wire burnt thru first, otherwise I'm certain it would have burnt thru.

The outer black sheath is mostly in tact.

The second pic shows the wire with the outer sheath removed. Insulation jacket was totally smoked, end to end.

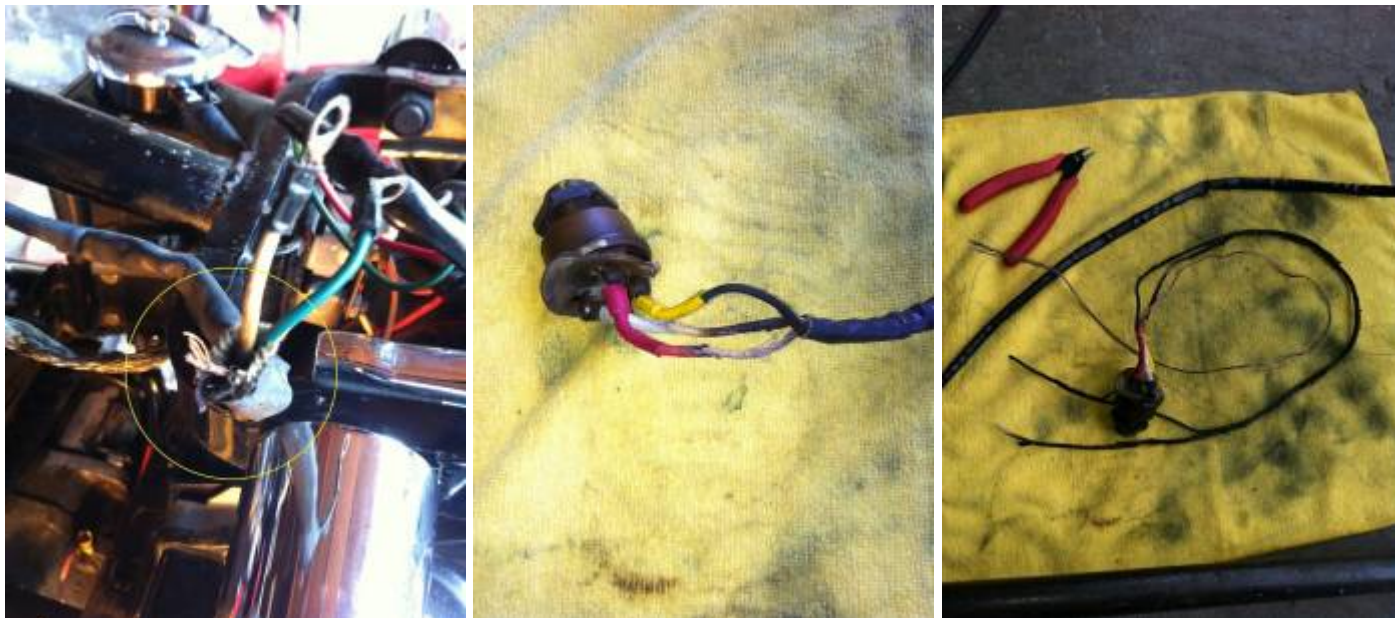
Below is what was left of the RED ignition switch wire (about 12 inches was damaged and/or evaporated), which runs from the voltage regulator to ignition switch.

The WHITE wire (feeds the accessory & ignition circuit breakers) and the GREEN wire (feeds lighting circuit breaker) were intact.

The outer black sheath housing the RED, WHITE & GREEN wires is mostly in tact except for the damaged 12 inches at the end.

Note the RED wire has all the insulation evaporated / melted off in the second pic below. The heat-shrink I installed 8 months earlier is more or less intact.

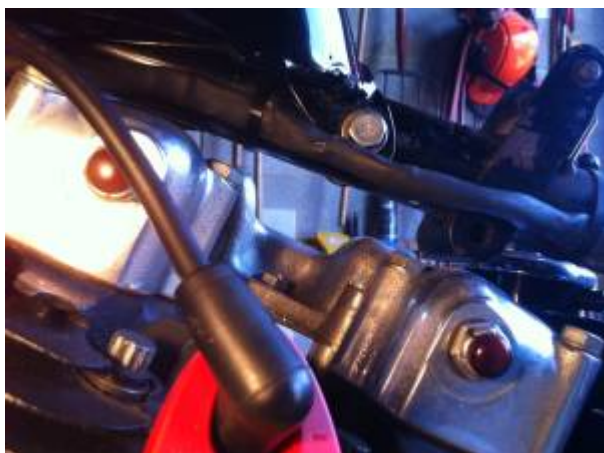
Here is the black sheath that houses the RED, WHITE, & GREEN wires running along the backbone of the frame.

The wires inside are "crispy & damaged to various degrees" but not burnt thru in this area.

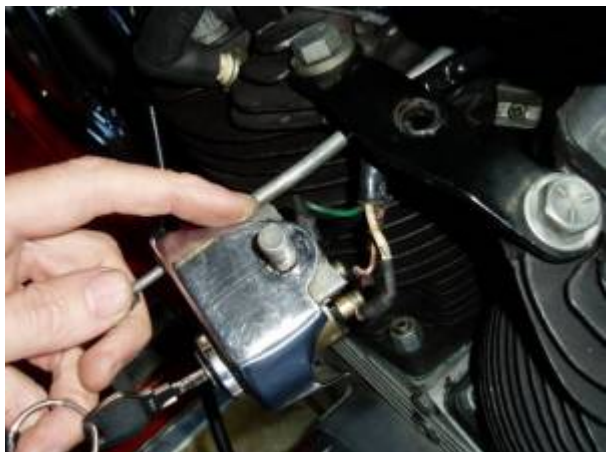
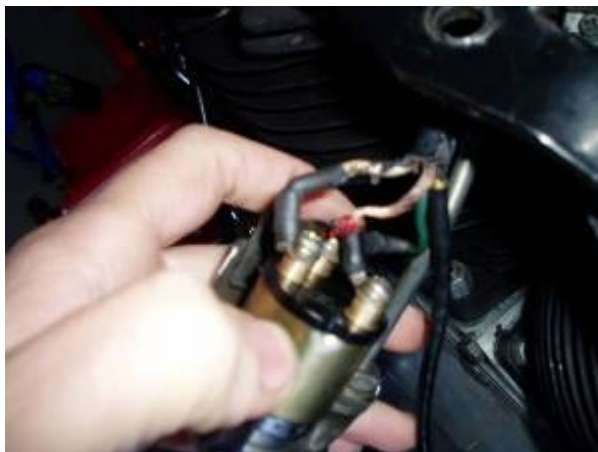
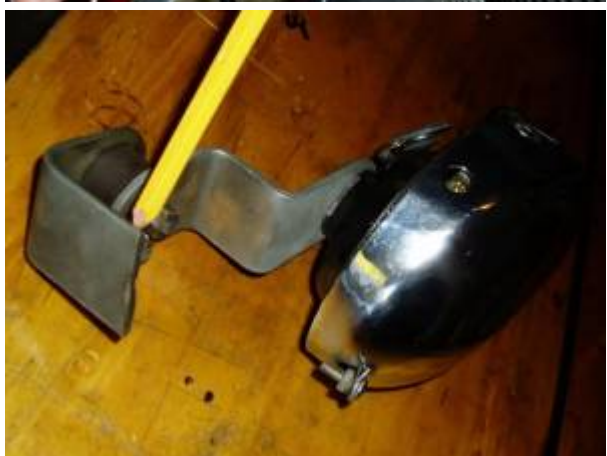
The highly conductive metal horn bracket has lobbed straight onto those bare screw connections on the back of the ignition switch.

It broke right where the thin (.080" or so) bracket stuck out past the heavy (3/8") bridge.

The bracket is sort of roughly chromed so it looks like there was some hydrogen embrittlement from the chroming.

That combined with HD vibration. Poor design that lets the bracket flex in use and the repeated heat cycles of the between the cylinder location.

The break is crystalized and you can see it was broke 3/4 of the way through for a long time before.

See that broken horn bracket right where my finger is pointing in the pic below.

And the bare terminals right below it. And the shiny copper wire direct from the battery, that used to have red insulation on it.

Well toasted. Nothing to insulate those terminals if something goes wrong.

In the third pic below is what fractured and fell down on top of those bare hot terminals.

A TIG weld repair with gussets should work to stop future flexing, and a properly insulated ignition switch set up will stop it from happening again.

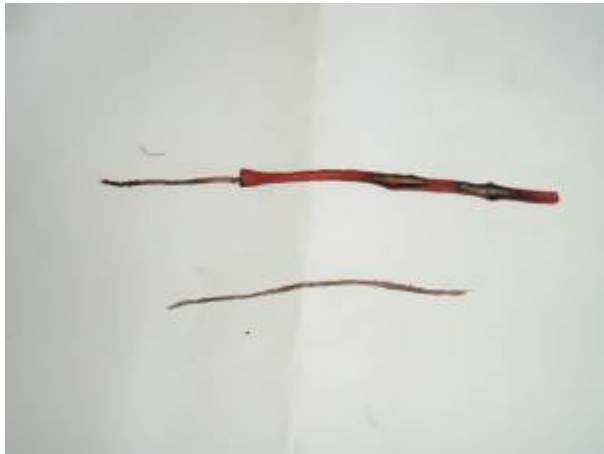
This is all that was left of the main power wire from the battery to the ignition switch.

A good foot of copper simply vaporized and disappeared.

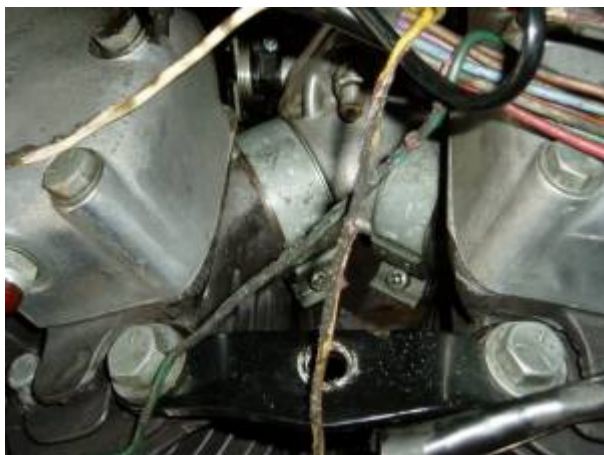
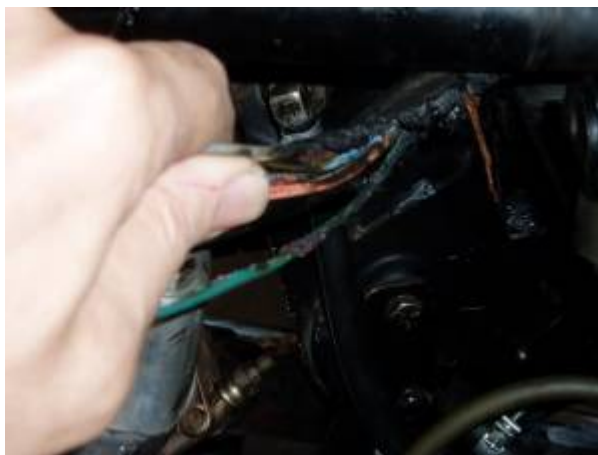
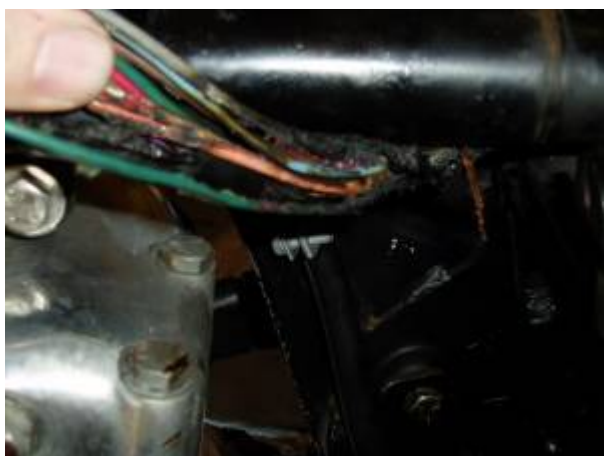
Nearby wires were well fried too, the ones going to the breakers after they leave the switch in the first pic below.

The others are the other end of the main loom going under the seat post area.

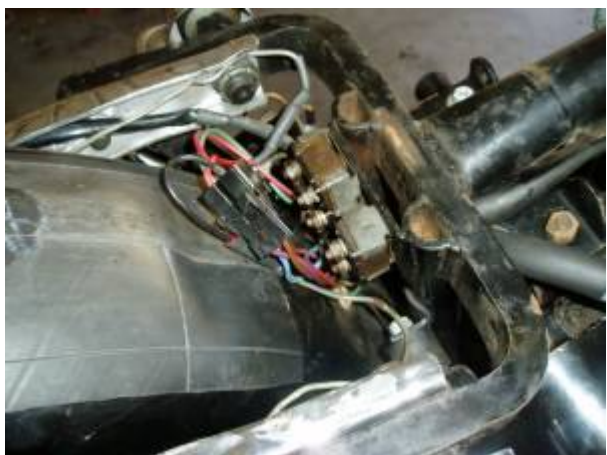
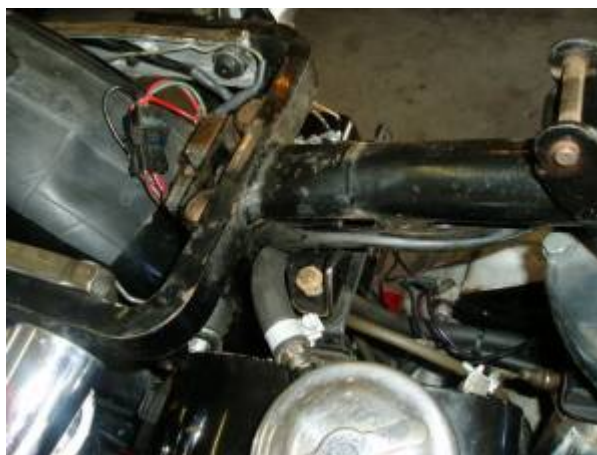
The rat's nest under the seat survived unscathed except the wires to the ignition breaker and lights breaker.

I added another fourth breaker, a 30amp job, right next to the battery so this cant happen again. The closeness of wires and terminals and steel frame and fender parts is absolutely terrifying. But I figure the master breaker right at the battery will prevent any meltdown if a bottle cap or something should blow in there off the road and arc those terminals.
