REF: Electrical System

Ironhead Wiring Mishaps and Meltdowns

Broken Horn Bracket

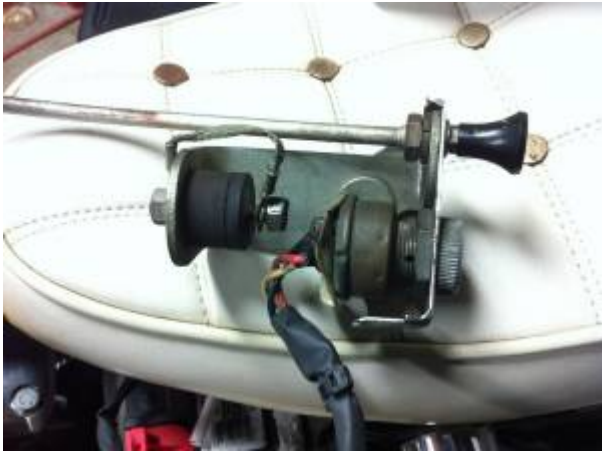
See the 'before' pic of the horn / switch brackets below (taken \approx 8 months prior to my catastrophic event).

The ends of the ignition switch wires were heat-shrink'd immediately after this pic was taken.

Note the exposed screws on the back of the ignition switch.

Before pic. Note the relative pristine condition of the horn mounting bracket, p/n 69129-72. ²⁾

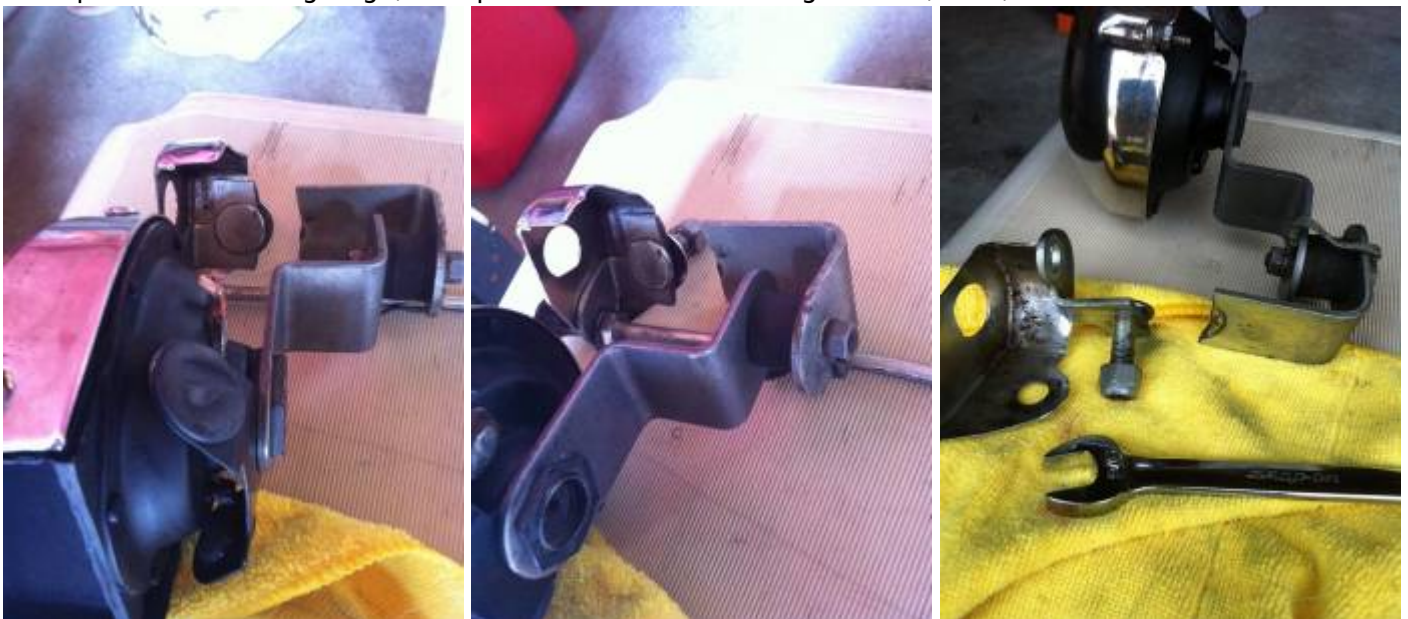
The fact of the bracket breaking (due to being loose, vibration, age etc,) isn't the problem (electrically speaking).

Should the horn bracket break, the horn will (most likely) swing down & rest on the back of the ignition switch for awhile, shorting the terminals.

The subsequent dead short heats up the wires, melting them and triggers the carnage shown below.

After pics. Back in the garage, with pics of the horn mounting bracket, et al, after removal. ³⁾

For the fix, I added a reinforcement to the horn bracket & TIG welded it up, replaced all those wires, & added my own fuse wire.

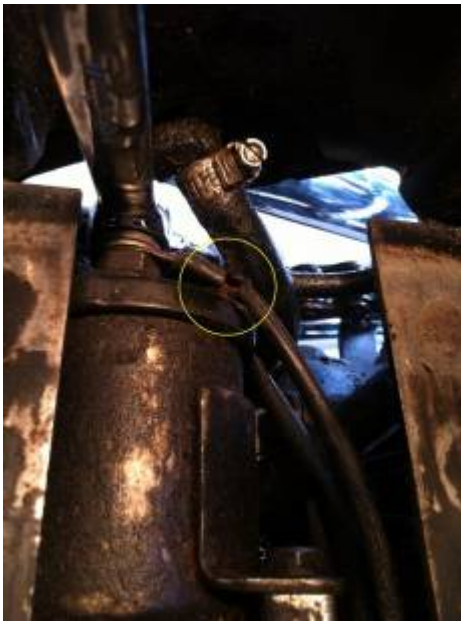
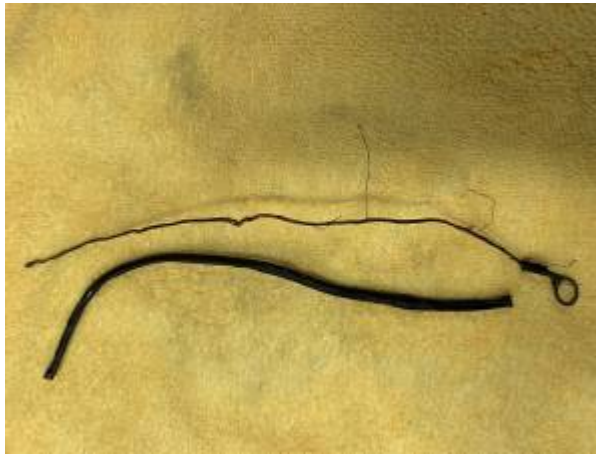
First pic below is the RED wire from the solenoid to voltage regulator, note the insulation (on what was the RED wire) has evaporated.

On a '74 XLH, this wire is the main feed that runs from the solenoid to the Delco voltage regulator. I fully expected this wire to be burnt thru. It wasn't. Another RED wire burnt thru first, otherwise I'm certain it would have burnt thru.

The outer black sheath is mostly in tact.

The second pic shows the wire with the outer sheath removed. Insulation jacket was totally smoked, end to end.

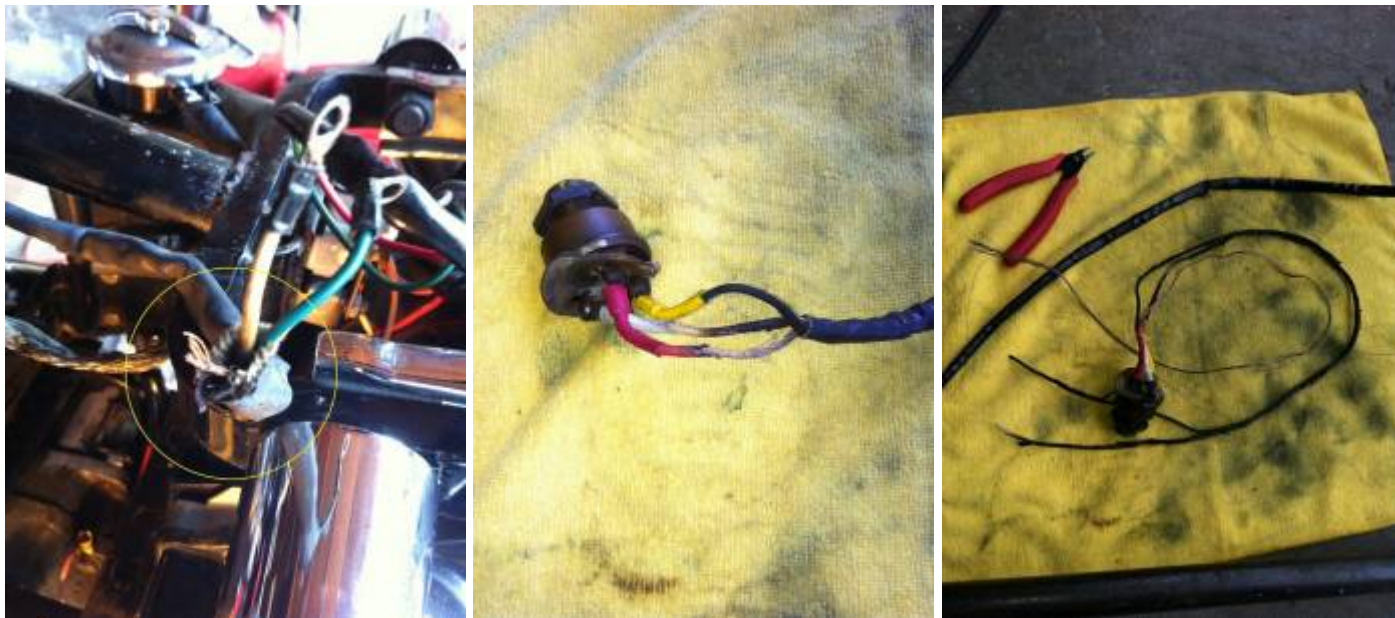
Below is what was left of the RED ignition switch wire (about 12 inches was damaged and/or evaporated), which runs from the voltage regulator to ignition switch.

The WHITE wire (feeds the accessory & ignition circuit breakers) and the GREEN wire (feeds lighting circuit breaker) were intact.

(although still damaged due to heat on RED wire)

The outer black sheath housing the RED, WHITE & GREEN wires is mostly in tact except for the damaged 12 inches at the end.

Note the RED wire has all the insulation evaporated / melted off in the second pic below. The heat-shrink I installed 8 months earlier is more or less intact.

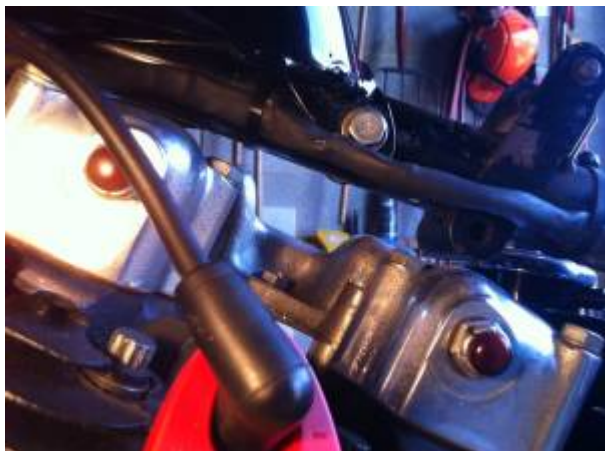
Here is the black sheath that houses the RED, WHITE, & GREEN wires running along the backbone of the frame.

The wires inside are "crispy & damaged to various degrees" but not burnt thru in this area.

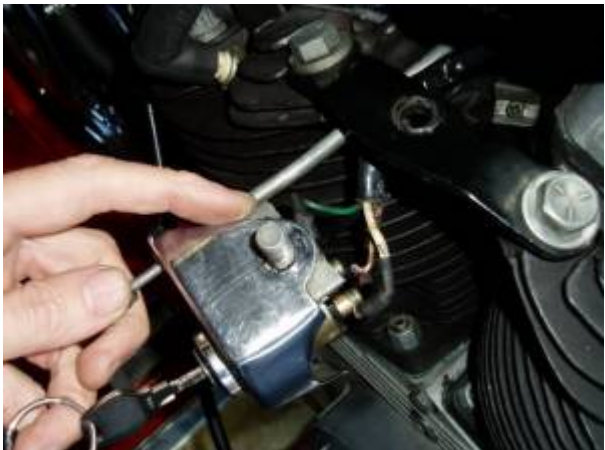
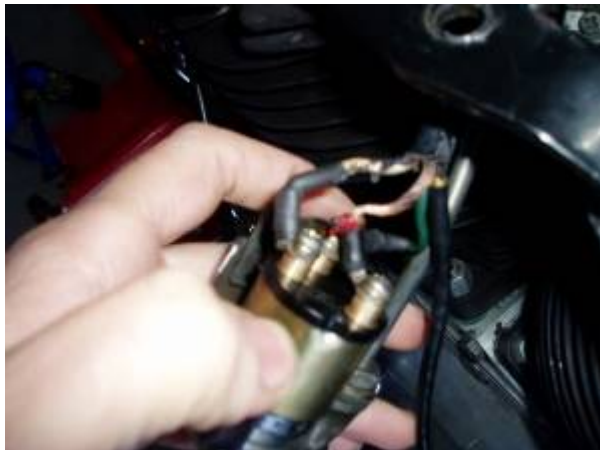
The highly conductive metal horn bracket has lobbed straight onto those bare screw connections on the back of the ignition switch.

It broke right where the thin (.080" or so) bracket stuck out past the heavy (3/8") bridge.

The bracket is sort of roughly chromed so it looks like there was some hydrogen embrittlement from the chroming.

That combined with HD vibration. Poor design that lets the bracket flex in use and the repeated heat cycles of the between the cylinder location.

The break is crystalized and you can see it was broke 3/4 of the way through for a long time before.

See that broken horn bracket right where my finger is pointing in the pic below.

And the bare terminals right below it. And the shiny copper wire direct from the battery, that used to have red insulation on it.

Well toasted. Nothing to insulate those terminals if something goes wrong.

A TIG weld repair with gussets should work to stop future flexing, and a properly insulated ignition switch set up will stop it from happening again.

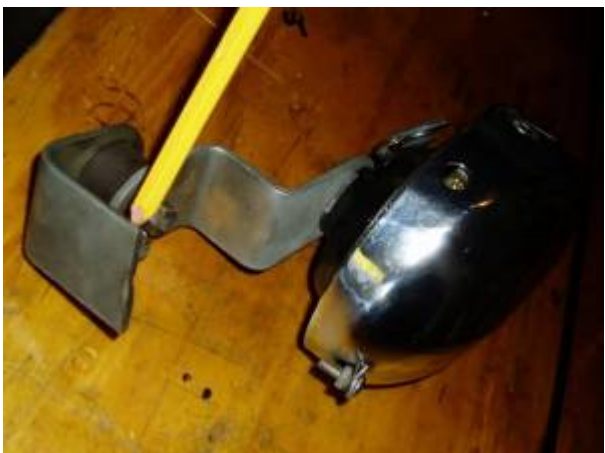
The part that broke was the top part that bolts to the big heavy bridge bolted between the two heads, and the rubber bobbin attaches to it.

In the third pic below is what fractured and fell down on top of those bare hot terminals.

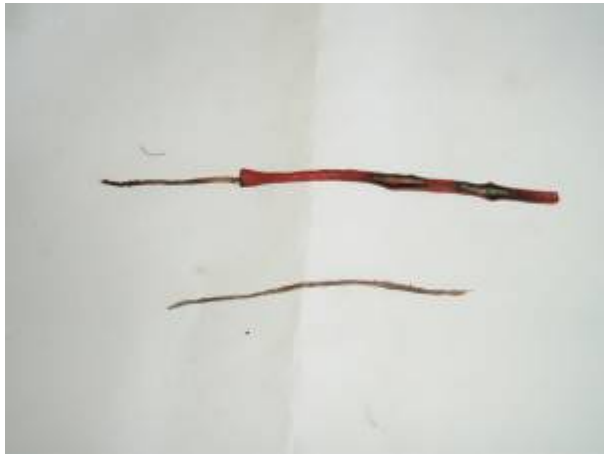
This is all that was left of the main power wire from the battery to the ignition switch.

A good foot of copper simply vaporized and disappeared.

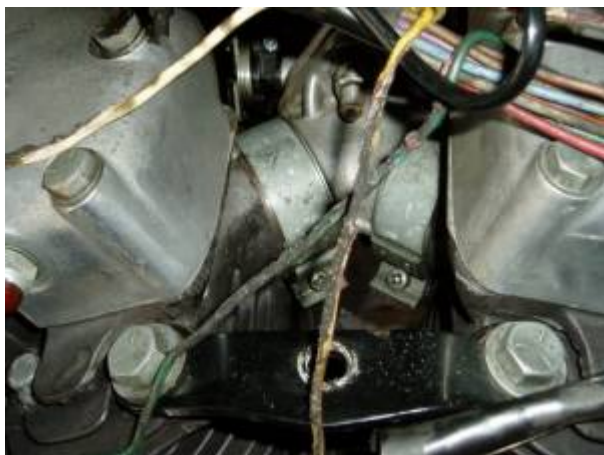
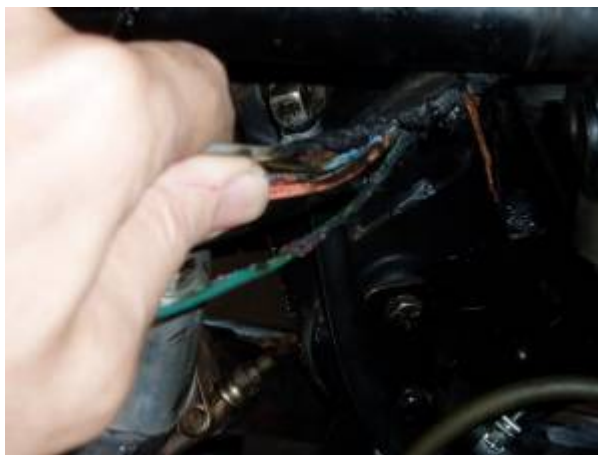
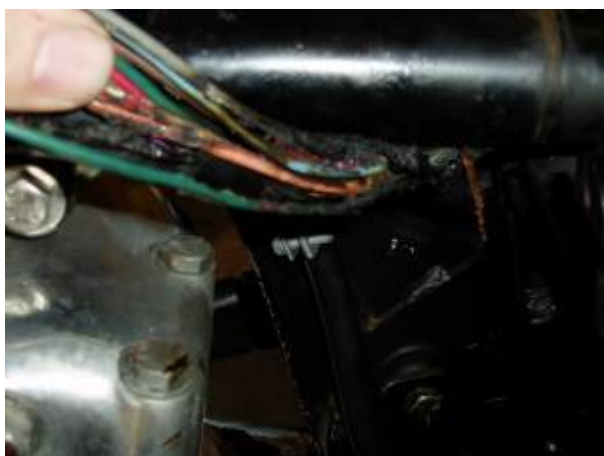
Nearby wires were well fried too, the ones going to the breakers after they leave the switch in the first pic below.

The others are the other end of the main loom going under the seat post area.

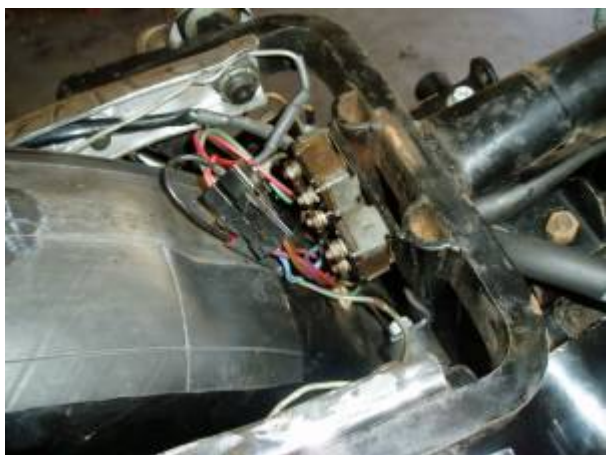
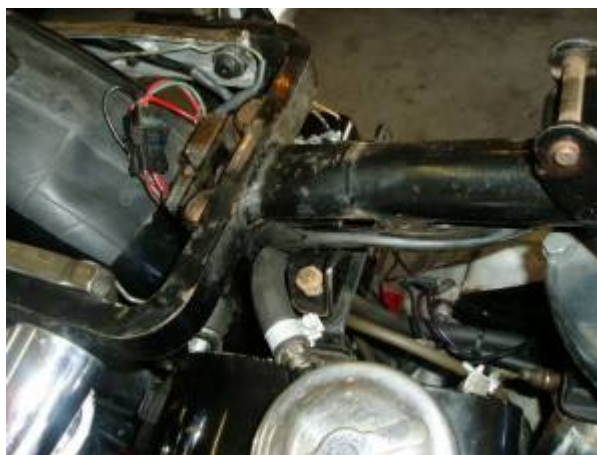
The rat's nest under the seat survived unscathed except the wires to the ignition breaker and lights breaker.

I added another fourth breaker, a 30amp job, right next to the battery so this cant happen again. The closeness of wires and terminals and steel frame and fender parts is absolutely terrifying. But I figure the master breaker right at the battery will prevent any meltdown if a bottle cap or something should blow in there off the road and arc those terminals.
