## REF: General-MSR 07

# Diagnosing Catastrophic Engine Failure in Evo Engines

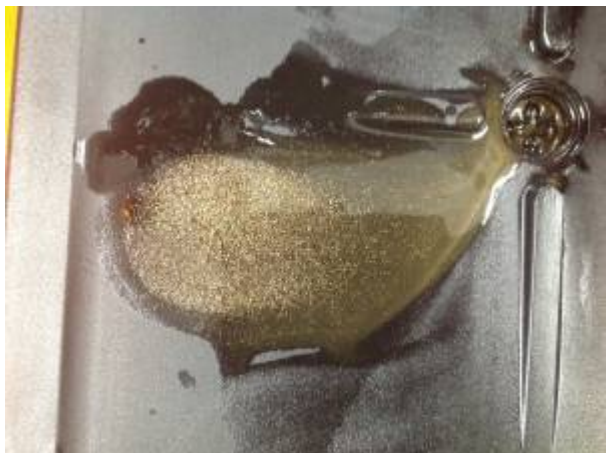
1)

If something like this comes out when you do an oil change, find out if it's metal or brass / bronze and start diagnosing where it came from.

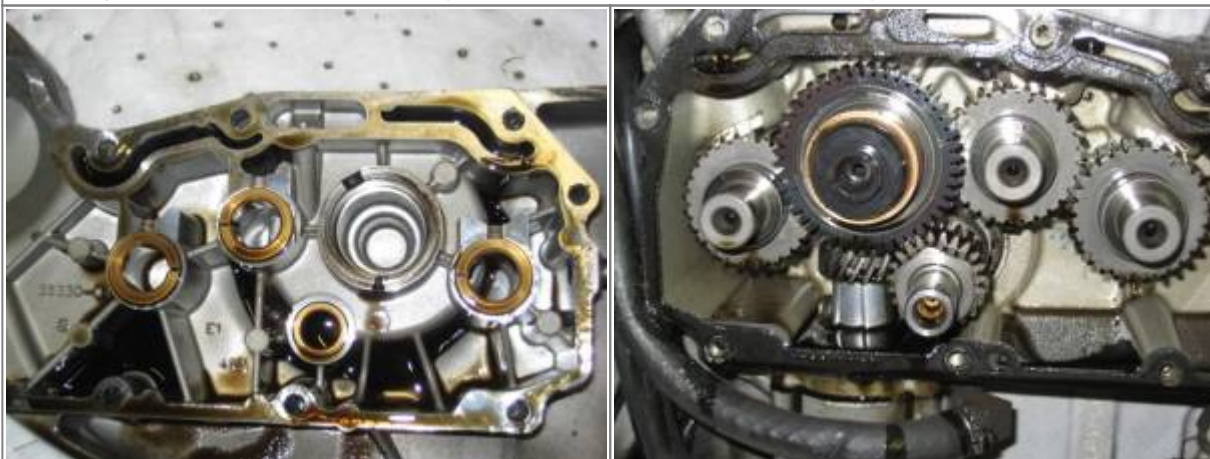
Spun #2 outer cam bushing, 2006 cam cover. Heat coloring on front of cam.<sup>13)</sup>

- **Repair.** When the bushings spin in the cases, they don't leave a perfectly round bore. As they spin, they rip/ream some of the bore I.D. and may move the bore center.

Finding that center with oversize bushings should be done by a qualified machine shop.

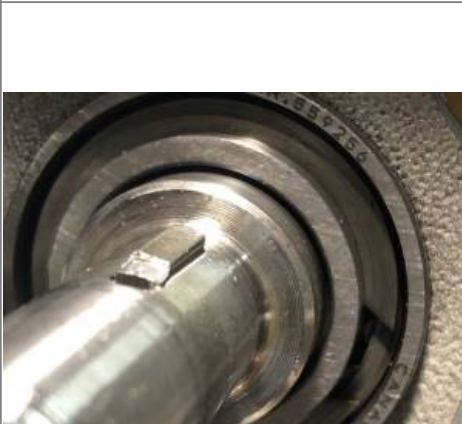
- In the pics below, the little nub of the key that protrudes from under the oil pump gear is the only portion of the key that engages the pinion gear. <sup>16)</sup> That's why it shears so easily if the nut is loose. There just ain't much holding it besides the clamp force of the nut. The clamp force from the nut holds the pump gear on, not the key.

Pinion key location <sup>18)</sup>	Condition of key after gear spins <sup>19)</sup>	Pinion gear spun (app 90°), stopped and still turned the cams from new location <sup>20)</sup>
  <p>The pinion gear is located by the little nub of the oil pump drive key that you see sticking out. With high valve spring pressures, this nub often shears off, sending pistons crashing into valves. Avoid this issue by torquing the pinion nut to 70lb-ft. Be sure to use Loctite red on the threads per the manual.</p>

<p>Pinion gear spun near 90 degrees?</p> <p>Key looks chamfered</p> <p>Spun Pinion Gear 2004 Sportster</p>

- When installing the pinion nut, use Loctite red per the manual, and torque it to 70ft-lbs. <sup>14)</sup> It's pretty rare to have the gear fail in a stock Sportster. You typically only run into this issue after hop-up work. The factory torque spec is 35-45 ft/lbs. which is too little torque for upgraded engines and often results in a sheared pinion key.

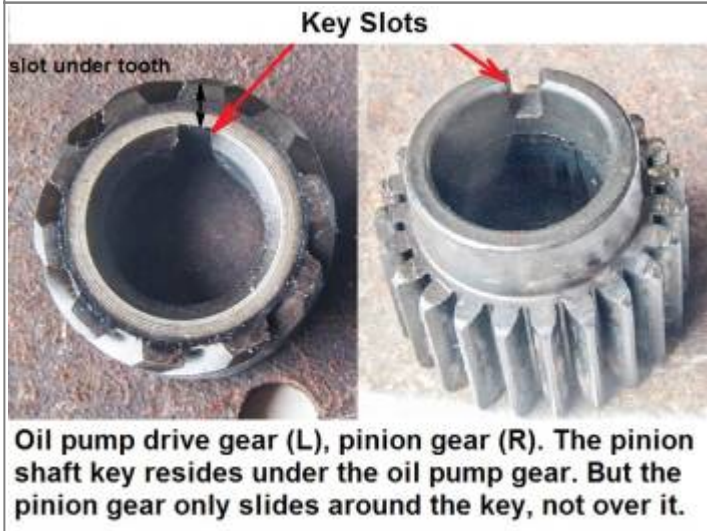
1988-up oil pump drive gear / pinion gear keyways. <sup>21)</sup>

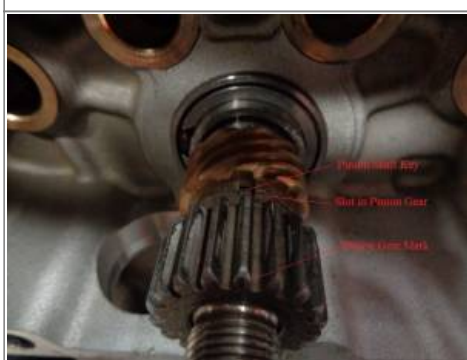
Pinion gear slot aligned with pump gear face. <sup>22)</sup>

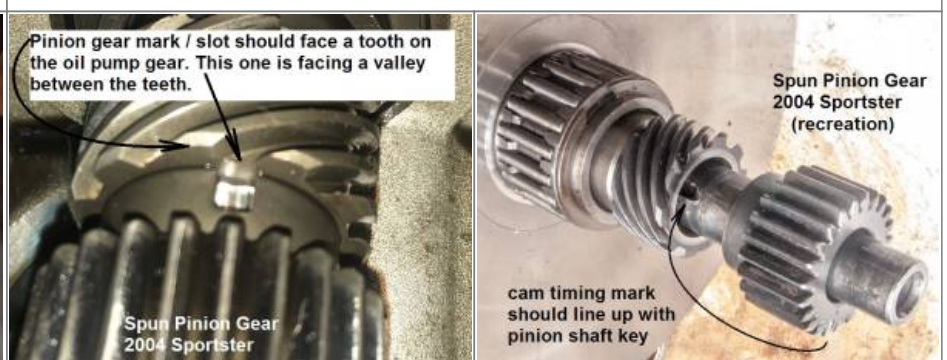
If the pinion gear slot is facing a valley (between two teeth) on the pump gear, the pinion key (at least the part that holds the pinion gear) has sheared.

And the pinion gear has turned to some degree out of time with the crankshaft.

Spun pinion gear. <sup>23)</sup>

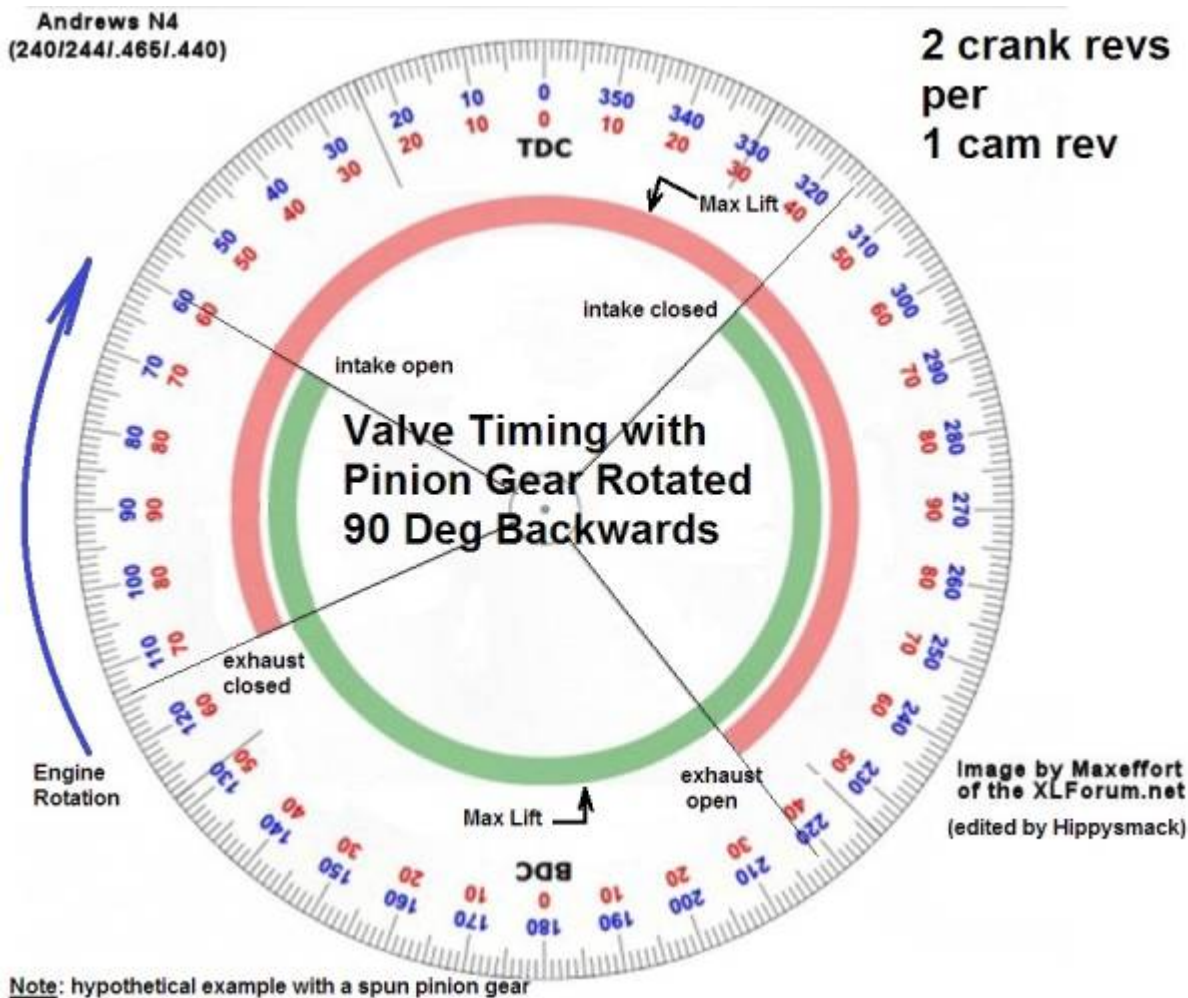
The intake cam lobe center (point of max lift) is now resting at app. 8° after BDC.  
 On the next TDC event (360° of crank movement), max lift (180° of cam movement) on the intake valve will occur at 8° after TDC.  
 Next TDC event, max lift will be back at 8° after BDC.

The exhaust cam lobe center (point of max lift) is resting at app. 20° before TDC.  
 On the next TDC event (360° of crank movement), max lift (180° of cam movement) on the exhaust valve will be app 20° before BDC.  
 Next TDC event, max lift will be back at 20° before TDC.

So in this example, the intake valve should take the first hit before the exhaust valve would due to the proximity to the piston during rotation.
