REAR DISC BRAKE / 1974 THROUGH 1976 FL, FX

HARLEY-DAVIDSON MOTOR CO., INC.

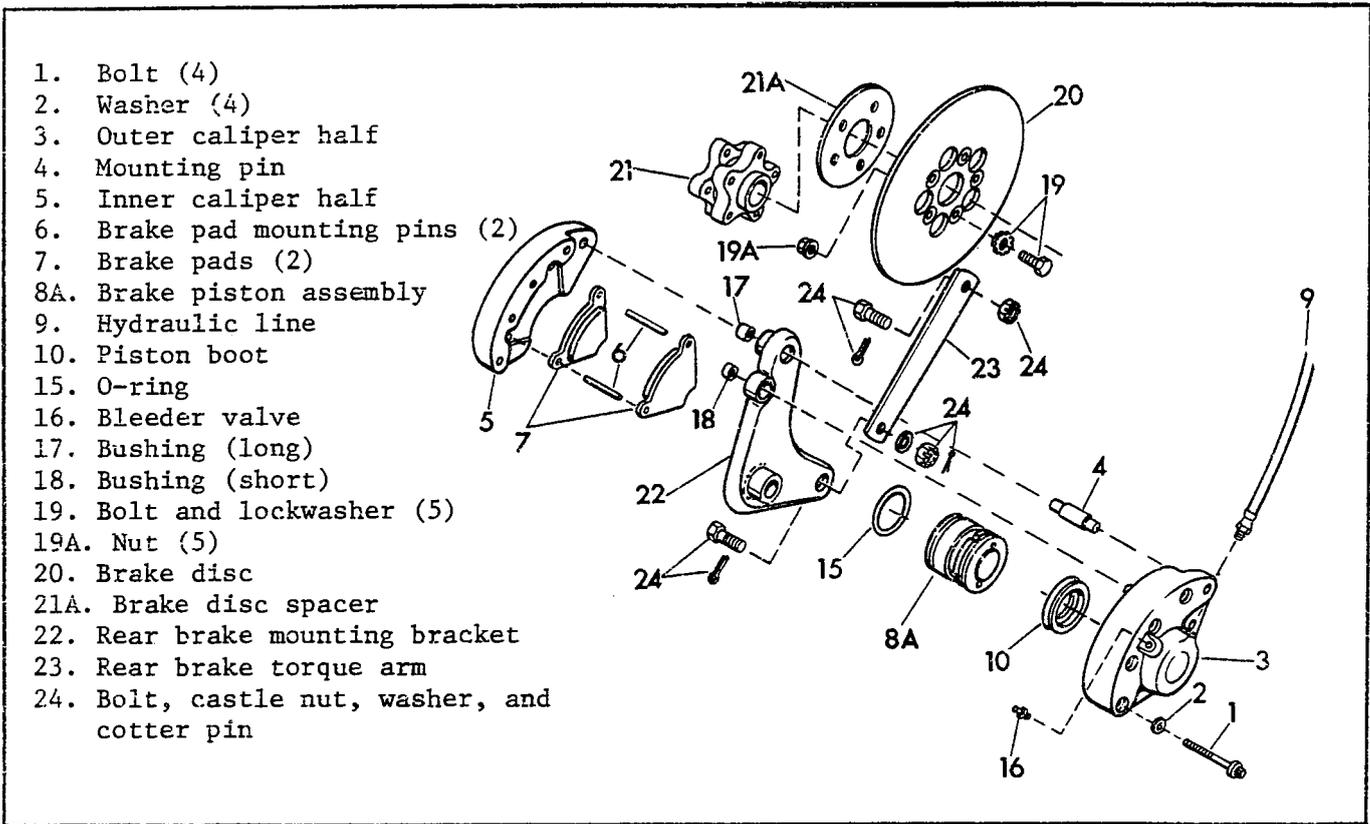
Figure 1. Rear Disc Brake

Certain 1200cc motorcycles produced during the 1974, 1975 and 1976 model season may have a defective rear brake system. Brake failure can occur on affected motorcycles because of heat generated at the rear wheel brake caliper when brake pads drag on the brake disc. The heat generated may vaporize the brake fluid into a compressible gas, causing the loss of effective rear brake pedal upon application. Partial or total loss of rear braking could cause an accident with personal injury. This failure could occur without prior warning.

The following special services must be performed on affected vehicles to improve and maintain caliper to disc alignment, which will eliminate drag and resultant heat build-up in the rear disc brake. Also, installation of silicone type (D.O.T. 5) brake fluid will minimize the vaporization problems if excessive heat occurs.

Referring to Figure 1, perform following steps as they apply to the affected vehicle being serviced.

1. Remove right saddlebag and left saddlebag supports.
2. Loosen fitting of hydraulic brake line (9) connected to outer caliper half (3).
3. Remove both outer and inner caliper halves (3 and 5) from rear brake mounting bracket (22).
4. Complete removal of brake line (9) from caliper half (3) by turning caliper counterclockwise.
5. Remove brake fluid presently in rear brake hydraulic system by pumping it out open end of brake line (9). Do this by stroking rear brake pedal until fluid ceases to flow.
6. Remove brake piston assembly (8A) from outer caliper half (3) by applying high pressure air into hydraulic line (9) hole.

7. Remove piston boot (10) from caliper half (3) and insert new piston boot (10), part No. 44133-72, into its groove in caliper half (3).
8. Install new O-ring (15), part No. 44127-72A, on new piston assembly (8A), part No. 44129-73.

9. Carefully insert new piston assembly (8A) through new piston boot (10) and into caliper half (3). Then install piston assembly (8A) by tapping with a soft hammer into caliper half (3) while at the same time positioning piston boot (10) into narrow groove of piston assembly.

10. Determine whether bushings (17 and 18) in brake mounting bracket (22) are Teflon or stainless steel. If they are stainless steel and in satisfactory condition, they need not be replaced; in this case, proceed to step 16. If they are Teflon, or stainless steel in worn condition, they must be replaced; in this case, perform step 11 through 15, below.

13. Press out Teflon bushings (17 and 18) with piston pin driver or other 11/16" dia. rod and press in new set of stainless steel bushings, part No.'s 45821-75 and 45822-75. For easy insertion, a slight chamfer can be ground on edge of each new bushing. Also, take care not to bend or distort bracket (22) while pressing bushings.

16. The rear brake caliper pads (7) must be in parallel alignment with brake disc (20). This is insured by having brake mounting bracket (22) correctly aligned. Check alignment and correct as follows:
