TECH TIPS #19

6/90

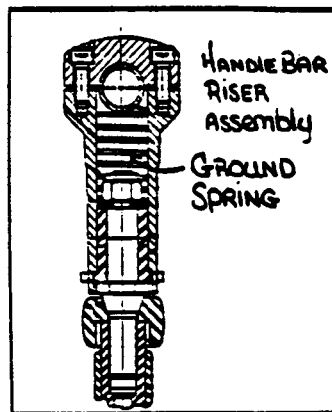
FXSTS:
HANDLEBAR
GROUND
SPRING

On 1/90 we started installing a spring inside the riser to establish a better ground. Because of the way we rubber mount the risers we experienced a ground condition that affected turn signal function. Should you experience a similar situation with vehicles (FXSTS) built before 1/90 please install this spring. Part number 46059-90.
