TECHNICAL TIPS #25
JUNE 1991

ALL MODELS

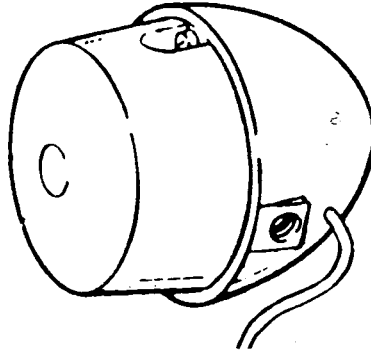
WATER (H2O) IN YOUR TURNSIGNAL ASSEMBLIES

Are your customer's turnsignal assemblies beginning to resemble a goldfish bowl or are there just localized heavy rainshowers taking place in there? Moisture retention can be eliminated by discarding the lens O-ring and adding two washers, pn 6717, between the lens and body.

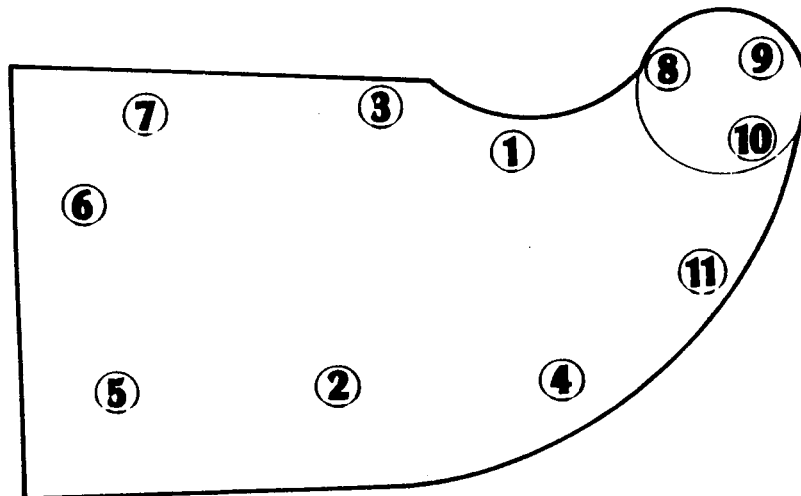
GEARCASE COVER TORQUE SEQUENCE

It is important that the gearcase covers on Sportster models be drawn to the crankcase as evenly as possible. Not only will this ensure sealing to the crankcase, but our testing has shown that it can have a positive impact on cam gear noise. During the initial assembly of the engines, Harley has begun using a new sequence for torquing the cover fasteners. It is recommended that field technicians also utilize this torque sequence. The fastener torque remains unchanged at 80-110 in/lbs.

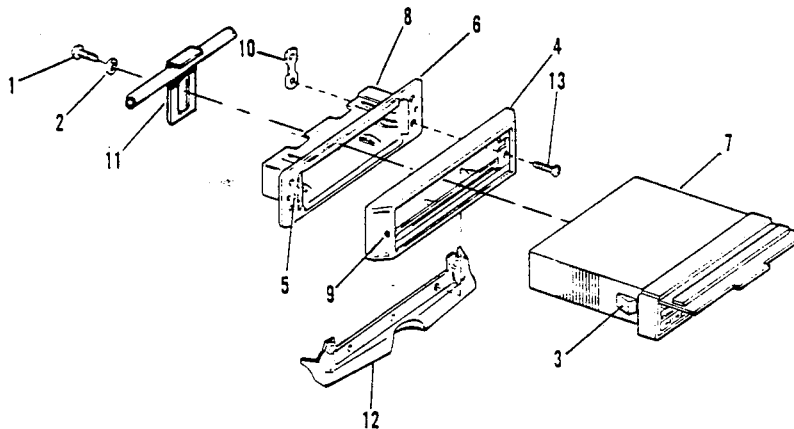
SOUND SYSTEM -- RADIO REMOVAL

Exercise extreme caution when removing radio assemblies for replacement. To access the spring clips on FLHT models, it is necessary to puncture the rubber seal at the index dimple, see picture- #9, with a #0 Phillips screwdriver. Failure to do this will scratch the sides of the nosepiece. If the radio nosepiece is damage or marred you will be billed for the damage!!!
