TECHNICAL TIPS #27  
OCTOBER 1991

\* SPORTSTER MODELS \*

1992 CYLINDER HEADS & HEAD BOLTS

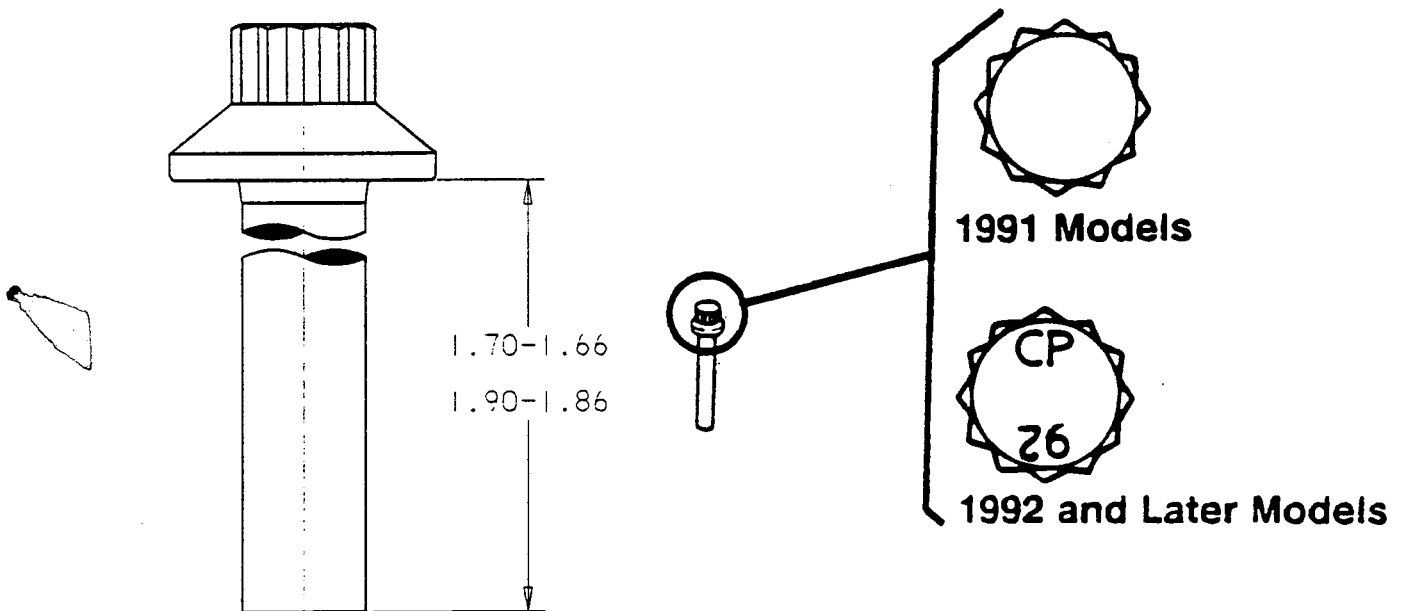
On 1992 cylinder heads, the head bolt counterbore, on the spark plug side, was reduced in depth. This change was made for ease of manufacturing. To maintain sufficient thread engagement, the head bolt length was increased. The new head bolts are identified with the number "92" on the bolt head. (1991-92 XL Service Manual-page 3-14) These new head bolts cannot be used on any vehicles other than 1992 Sportsters.

A small quantity of early 1992 Sportsters were built using the longer head bolts that DO NOT have the "92" identification on them. The only way to tell these from 1986-1991 bolts is by measuring the length. ( see illustration). Remember, this affects only early 1992 XL's.

The new cylinder heads are sold as a kit, with the bolts, to retrofit to 1991 vehicles.

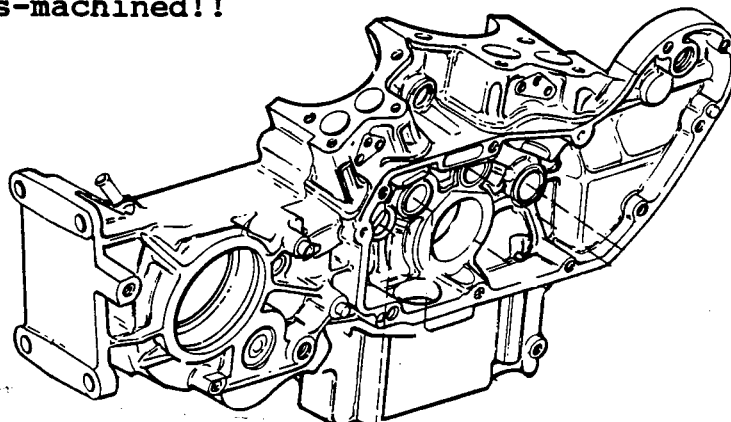
The oiling system by-pass has been eliminated from 1992 Sportster crankcases. This change was made to "borrow" oil for the cam gear oiler in the gearcase compartment. All 1991 replacement crankcases will also have these two features. The crankcases are not mis-machined!!

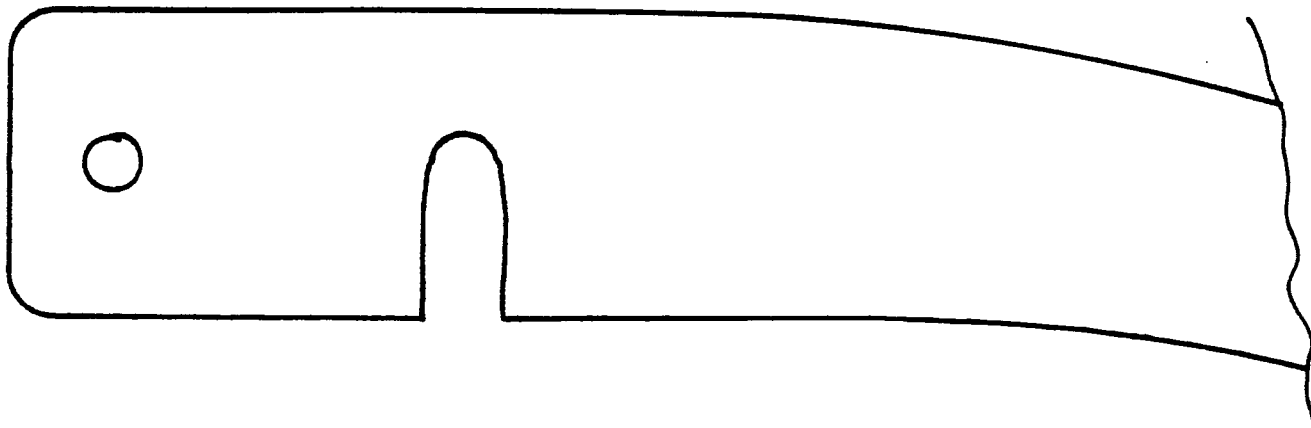
LET'S PLAY THE SLOTS!! , not VEGAS - FENDER STRUTS!!!  
Fender struts were added in 1990 to provide rigidity to the rear fender.  
In late September, the struts were slotted to make servicing and accessory installation easier.
