TECHNICAL TIPS

- OCTOBER 1992 -

#32

TECHNICAL TIPS # 32
OCTOBER 1992

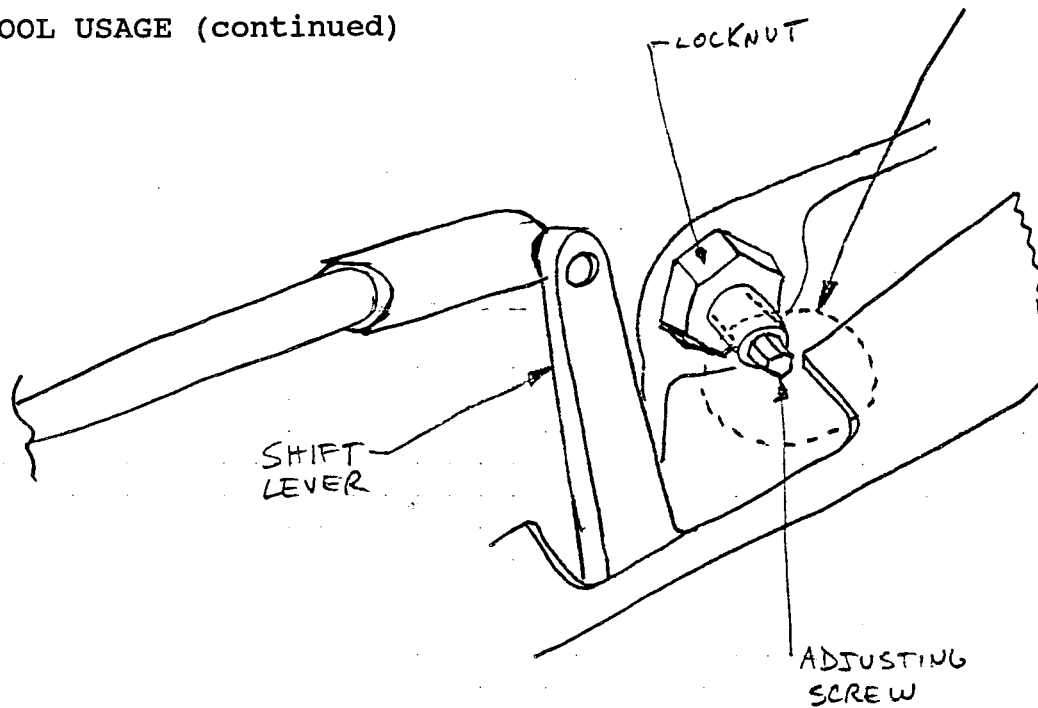
Due to tolerance stackups, it is possible on some early 1993 Softtail models that the inner primary may be so close to the new style transmission pawl adjuster that the new pawl adjusting service tool cannot be used.

A die grinder can be used to remove a small amount of material from the inner primary lip to permit tool's usage to adjust the shifter pawl linkage.

Changes have been made to the inner primary in order to eliminate any potential interference problem.
