TECHNICAL TIPS # 33

JANUARY 1993

TABLE OF CONTENTS

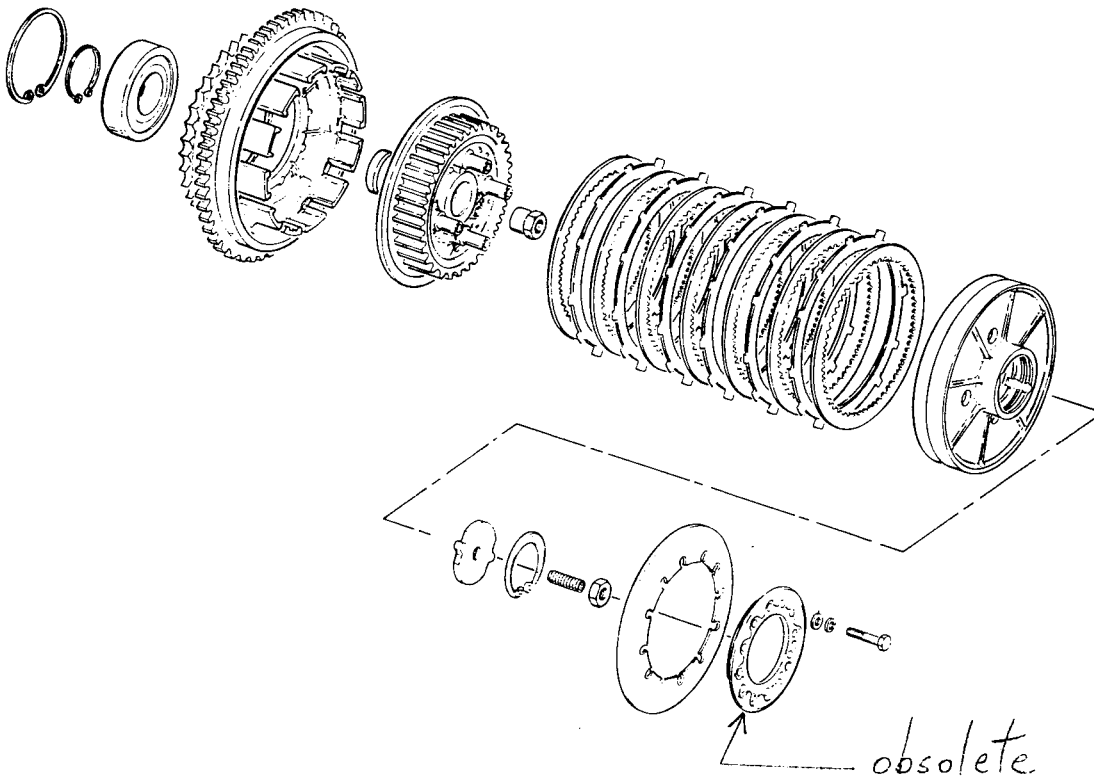
SERVICE PARTS FOR EARLIER 1340 CLUTCHES

There have been some changes in the availability of repair parts for the clutches used on 1340 models from 1984 1/2 to 1989. The adjuster plate, part number 37902-82 has been obsoleted and replaced with a kit. Part number, 37902-86B, this kit contains a new adjuster plate, 37902-89 and washers, 6069, which permit adjustment of the diaphragm spring pressure as with the earlier style of plate.

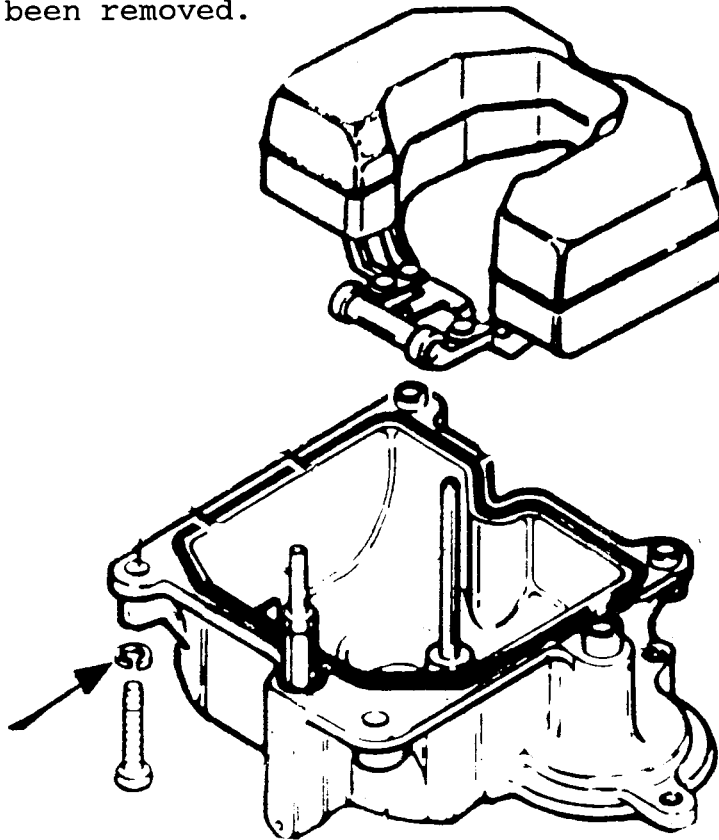
REPLACEMENT CARBURETOR PARTS

Replacement screws for carburetor float bowls can be ordered in packages of four, using part number; 27579-88A. The replacement screws will NO LONGER have the captive lockwashers that were used previously. Testing has shown that the lockwashers were not necessary and they have been removed.

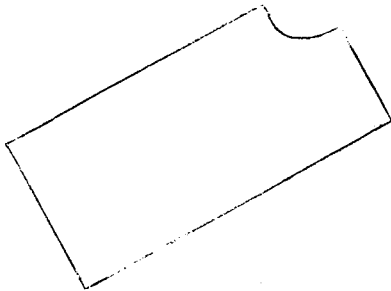
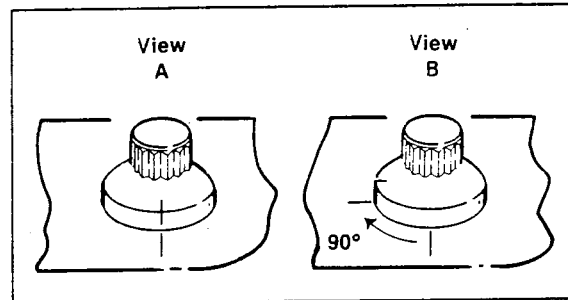
Figure 3-25. Tightening Head Screws

Service Technician, Mike McKeown, from Eastside Harley-Davidson, has found an easy way to ensure consistency when installing Evolution cylinder heads.

Mike fashioned a small template from plastic. The template gives a consistent positioning of the reference marks needed for the final 90 degree turning of the cylinder head bolts.
