**T  
E  
C  
H  
N  
I  
C  
A  
L  
T  
I  
P  
S**

**– July 1993 –  
#34**

# TECHNICAL TIPS # 34

## JULY 1993

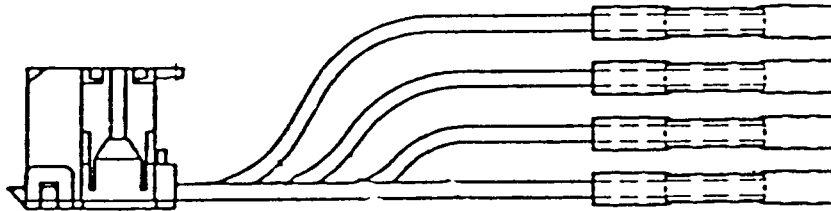
### *NEW HEADLAMP/ NEW PLUG*

1992 and later Sportsters and FXR's have utilized a new style headlight bulb. Because the headlight assembly is slightly larger in size, the plug was also changed to maintain clearance inside the headlight bucket.

This new style of plug is available as a retrofit kit. This is especially important if you are retrofitting the new bulb to an older vehicle. Part number, **68705-93**, the headlamp plug assembly is pre-wired and butt splice connectors complete the connections to the existing wiring.
