TECH TIPS #38

FEBRUARY 1994

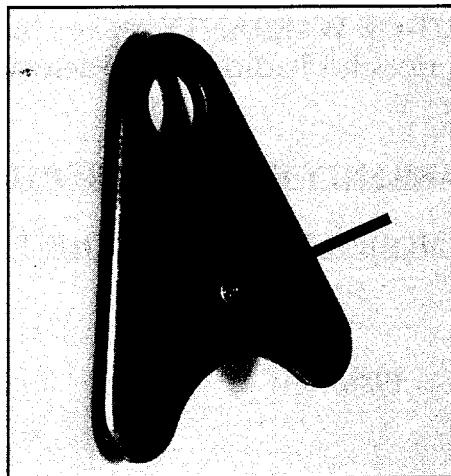
SHIFT DRUM PLATE

Beginning in early December 1993, a running production change was made to the location of the transmission shifter drum plate pin, part number,600.

This pin is used to locate the shift drum retaining plate. The pin **was** press fit into the transmission access door. It is now a part of the plate assembly. The new pin/plate assembly part number is 33178-90A. It can be retrofit to all earlier five speed XL models (1991 to early 1994) by removing the existing pin from the access door.

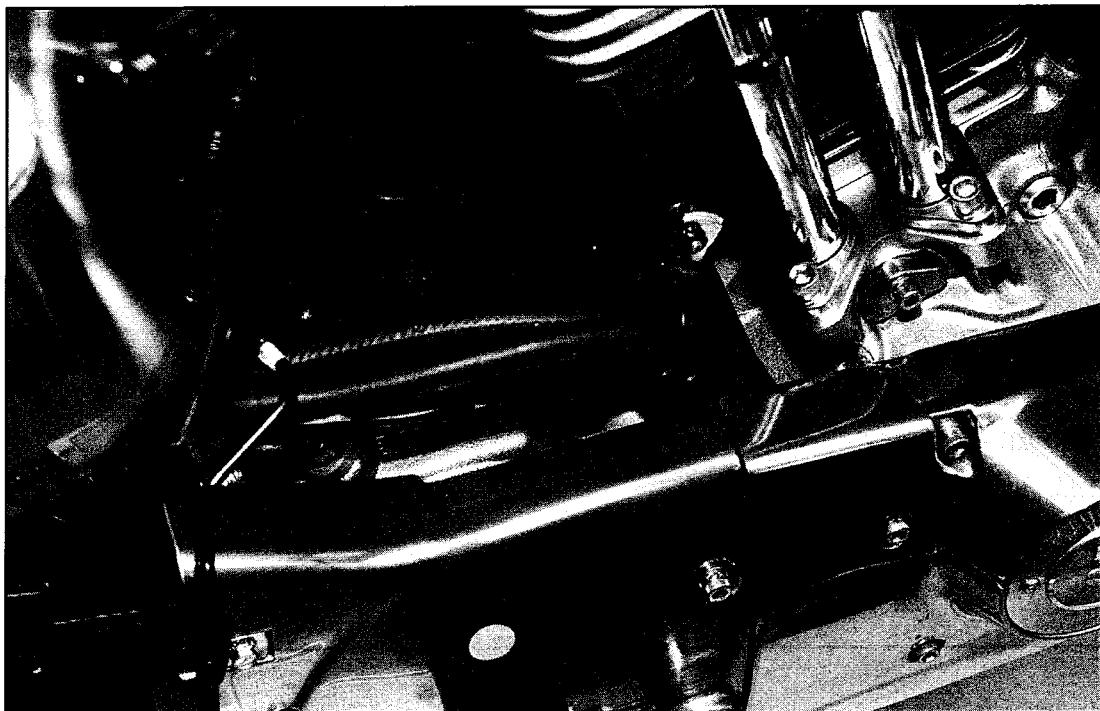
STARTER MOTOR/ OIL HOSE ROUTINGS

Beginning in late February, ALL XL vehicles will be equipped with 1200cc style starter motors. This will be done as a running production change.

In conjunction with this change, a simplified routing of the oil return and vent lines will also be made. Both hoses will now be routed above the sprocket cover on their way to the oil tank. This will eliminate the earlier routing underneath the engine (return hose) and underneath the starter motor (vent hose). The hoses will be secured to the starter motor with a new clamp, part number 31532-94, as part of the new routing.

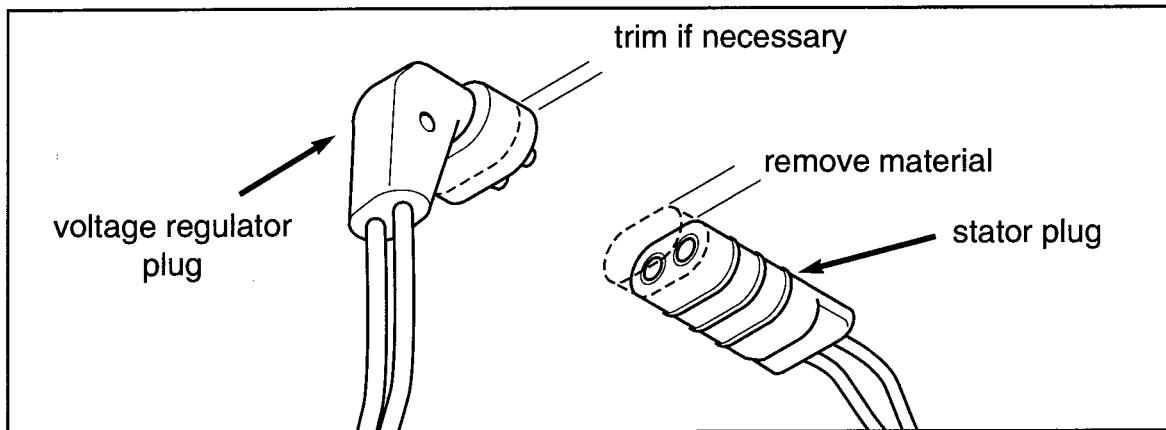
STATOR PLUG IMPROVEMENT

Norm (Wink) Winkler from Ukiah, CA. had a really excellent suggestion for increasing the pin/socket engagement of the stator and voltage regulator plugs. This greatly reduces the likelihood of plug separation and all the other bad things that come along with it.

Norm trims the stator plug rubber material until it is flush with the top of the stator's sockets. Engagement is increased by approximately .050" (1.27mm). You can really feel the difference and these connectors aren't going to fall apart!!! When you do this modification, make certain that the voltage regulator plug doesn't touch the crankcase. If it does, just trim it back slightly.

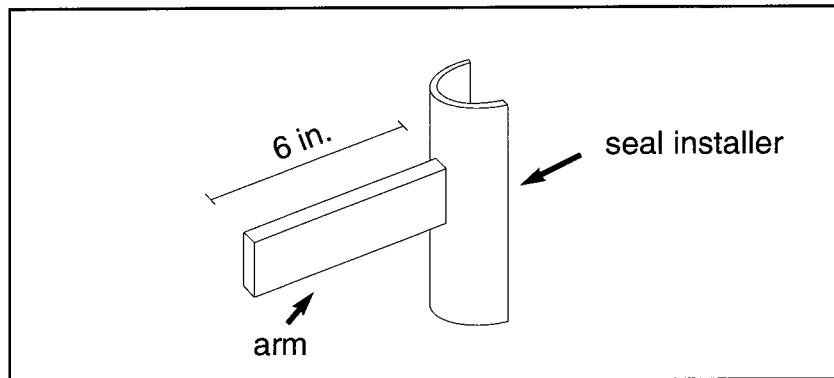
TOOL MODIFICATION

Russ Loy, technician at Neidengard's Cycle Center in Wintersville, Ohio, has modified a Kent-Moore Tool (HD-36583) reducing the time to install replacement fork seals. Russ has cut the existing tool in half and welded a 6" (15.24cm) arm to the tool's side. Russ taps the seal into place using the arm itself. This is especially useful when dealing with models that have decorative chrome covers and space is limited.
