# TECHNICAL TIPS

October 1994  
TT#40

# **TECH TIPS #40**

# TECHNICAL TIPS #40

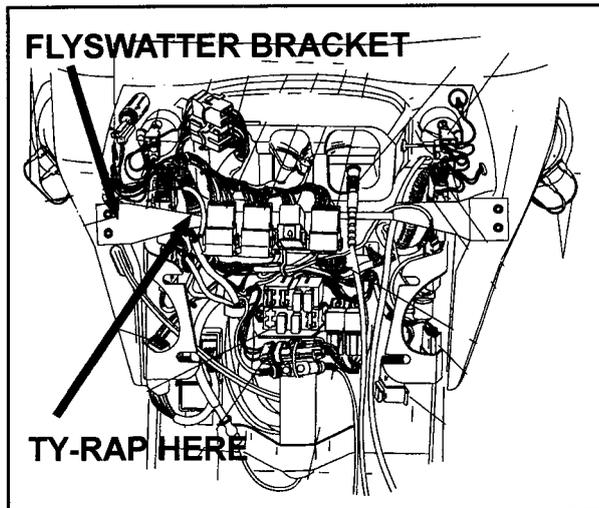
Figure 1

Prior to the November change, 94 Ultra fairing speaker switches sought their ground through a black/green wire which, via several splices, ran to the ground bolt located above the starter. This route proved to introduce too much "electrical noise" into the headset through the pod. The speaker switch now obtains its ground directly from the back of the radio chassis. An early 94 Ultra can be

ground directly from the back of the radio chassis. An early 94 Ultra can be updated in the field by following these steps:

- 1) Remove the black/green wire from the speaker switch's center terminal, tape and secure it, since it will not be reused.
- 2) Fabricate a black 18 gauge wire, 12 in. in length Strip 3/16" to 1/4' off of both ends. Crimp a terminal, part number 9858, on one end using a Packard 115 crimper, HD-38125-8, and the 20-18 gauge crimp die for the core and insulation crimp. Crimp a terminal, part number 9937, on the other end using a Packard 271 crimper, HD-38125-7, and the "C" die for the core crimp and the "D" die for the insulation crimp. Connect the wire to the center speaker switch terminal and to the lug at the rear of the radio chassis where the chassis's own ground wire resides. Hook it up. You're done.

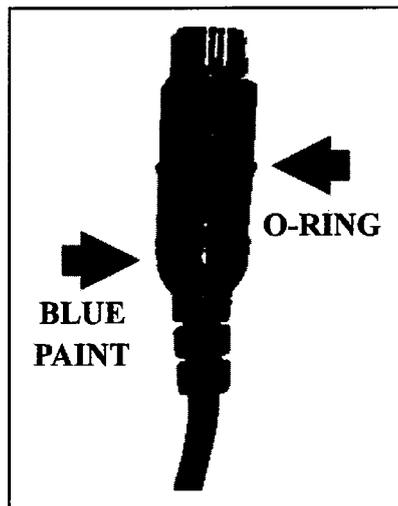
Figure 3

This last point applies only to 1993 Ultras that exhibit ignition tick. Any 1993 Ultra built during the period December 1992 to March 1993 could be equipped with a suspect DIN extension cable, part number 76292-92A. **Any sealed type DIN extension cable (sealed referring to the presence of the o-ring and it's groove) that does not have a blue paint dot as shown in figure 3 is suspect.** These suspect cables were manufactured with an ineffective shielding system and may allow electrical noise to enter the console control pod circuits. Replacement of this cable with a "blue dot" cable (76292-92A) from P&A will eliminate the ticking. P&A stock has been purged of any non blue dot cables.
