TECHNICAL TIPS

April 1995
TT#42

TECH TIPS #42

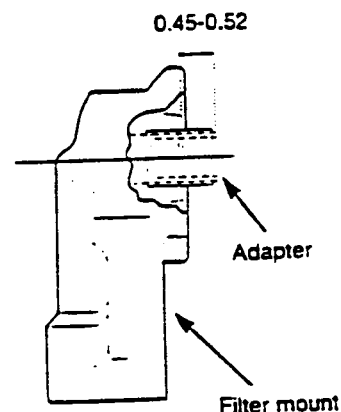
OIL FILTER MOUNT

When replacing oil filters during service intervals, please check to see that the oil filter adapter has a sufficient amount of threads protruding to properly engage the oil filter. The correct thread length should be between 0.45 to 0.52 inches.

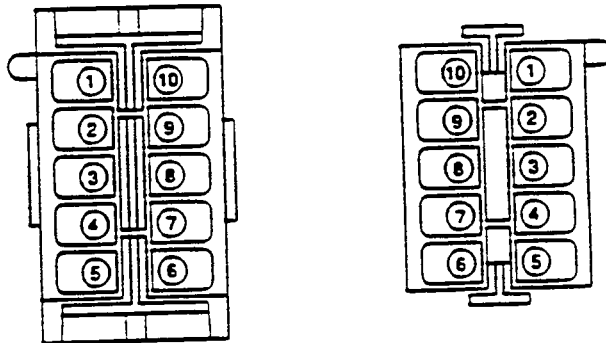
Amp Numbering System A: Sound System & Cruise

The 1989-1994 cruise and sound system troubleshooting terminal numbering system started with number 1 at the index lug and rotated in sequence either clockwise or counterclockwise, depending whether the connector was a pin or socket housing.

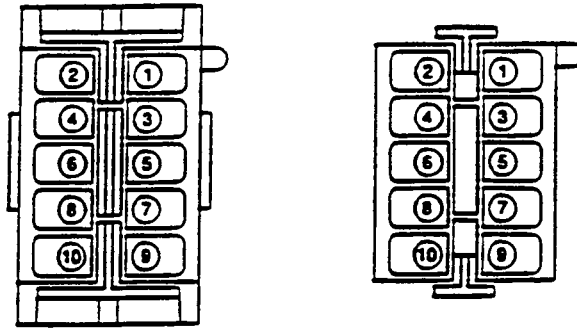
Amp Numbering System B: Turnsignal Module

The system used on the turnsignal module starts with number 1, at the index lug, and has odd numbers on the index lug side and even numbers on the other side of the connector. This system is actually closer to reality and can be verified when looking closer at the terminal side of the housing. On some connectors, the numbers are molded right into the housing! This should make troubleshooting easier. **All the 1995 Service manuals and wiring diagrams now follow System B when you look at Amp connectors.**
