January 19, 2004

Crank Position Sensor Change

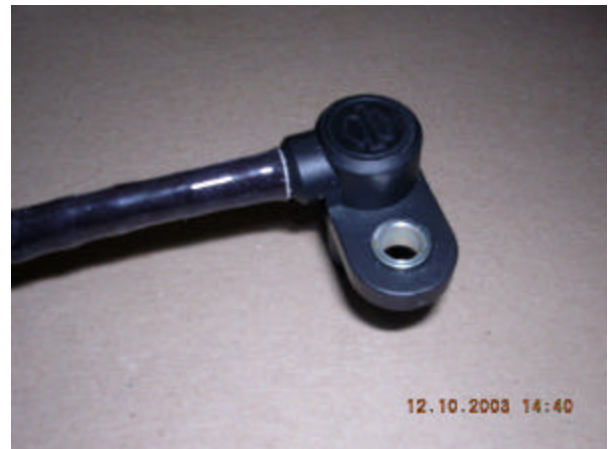
New Crank Position Sensor

We are changing our supplier for the Twin Cam crank position sensor. The new sensors have a different appearance and you will see them on production vehicles built in February 2004. You will begin to see the new sensor in P&A shipments this month. As P&A inventory is depleted all sensor part numbers will be superseded to an "A" suffix. The sensors are interchangeable so do not return or scrap the sensors in your inventory.
