January 31, 2005

Springer Softail Labor Code Update

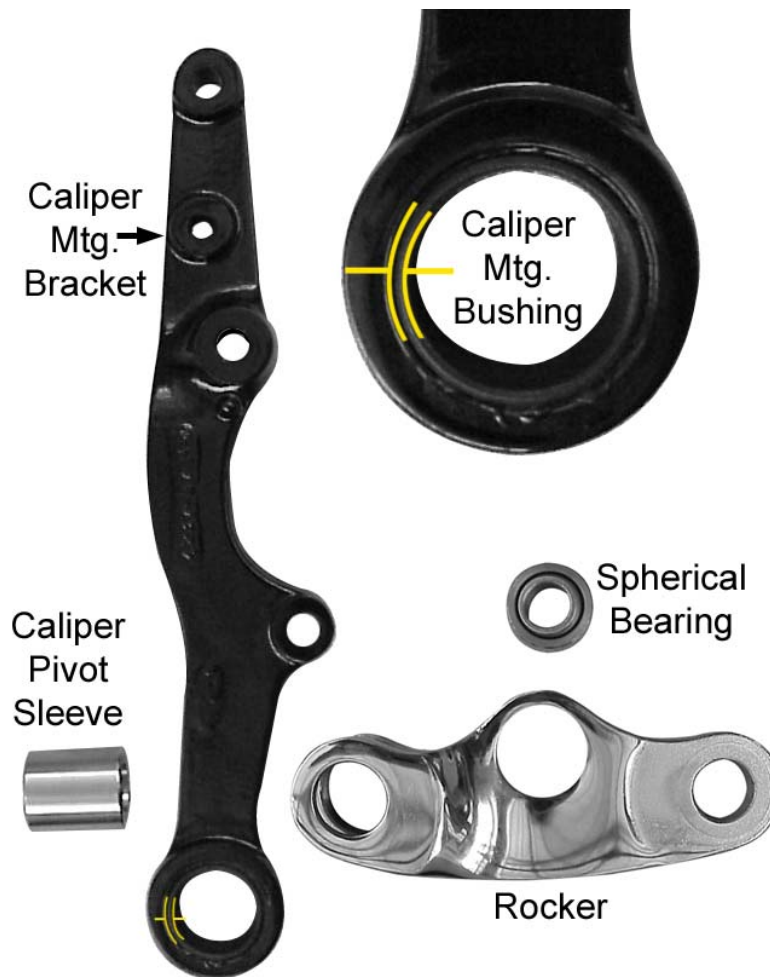
If you do have to perform a rocker bearing adjustment it would be a good idea to check the pivot sleeve in the caliper bracket and the spherical bearing in the rockers for binding also.

- ◆ If the caliper pivot sleeve is binding in the caliper mounting bracket you should replace the caliper mounting bushing. When the bushing is pressed out, inspect the bore and make sure there is no powdercoat in the bore before pressing in a new bushing.
- ◆ If the rocker's spherical bearing does not move freely insert the pivot stud into the bearing and work the bearing back and forth a few times to free up the bearing.

The caliper mounting bushing part number for the FL Springer model is 44086-97. This part number was not listed in the 2005 Softail Parts Manual so I would recommend adding it to your manuals. The FX Springer model caliper mount bushing is part # 44030-88A.
