## 2006 Dyna Model Wire Harness

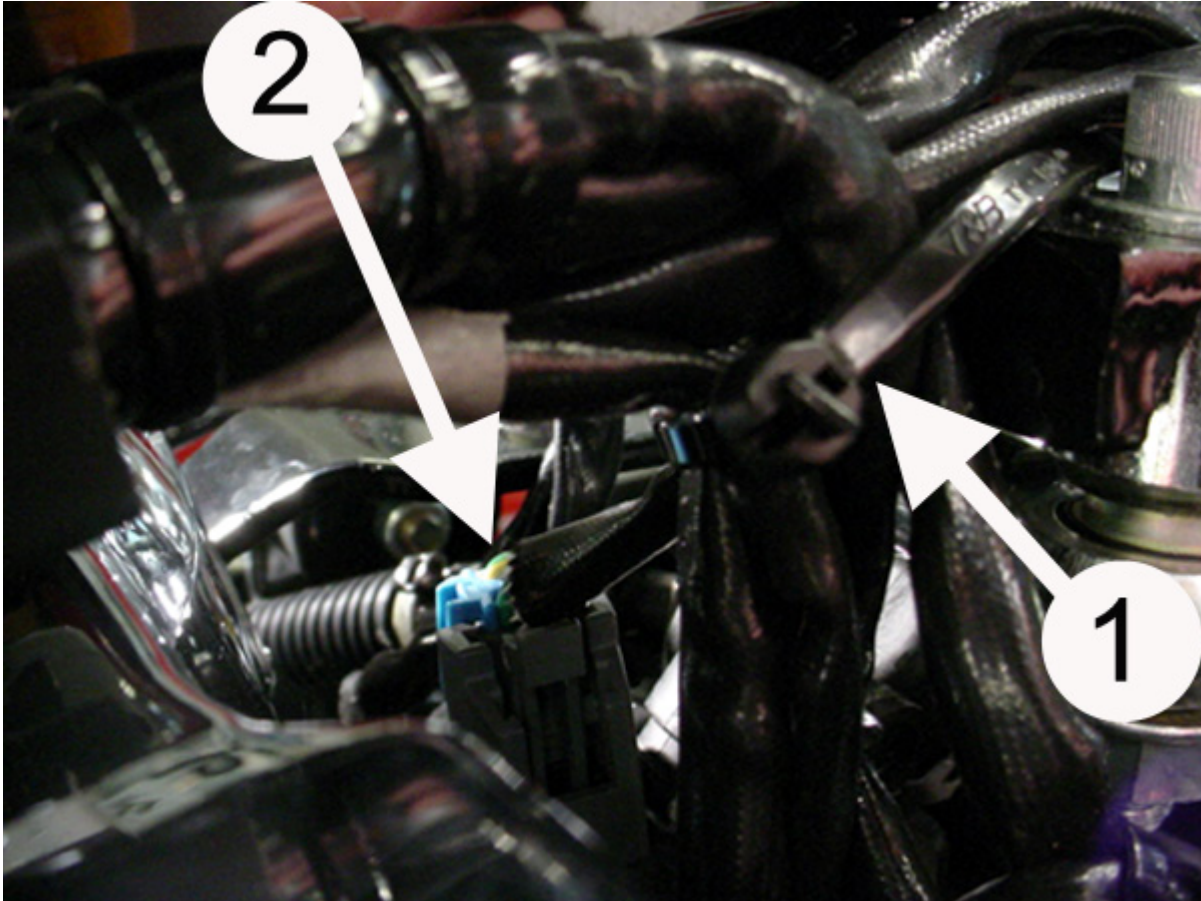
There is a possibility that the cable strap (1), shown in the picture below, may be applying undue pressure to the Engine Management sensor wires (2) and may cause an inferior connection. It is recommended that you remove the cable strap on any 2006 Dyna Model built on or before October 20, 2005 at PDI or at the next service. The Process for the cable strap has been changed on the assembly line to address this issue.
