TT252 – July 25, 2006

## 07 XL Sportster Engine Temperature Sensor Wire Routing

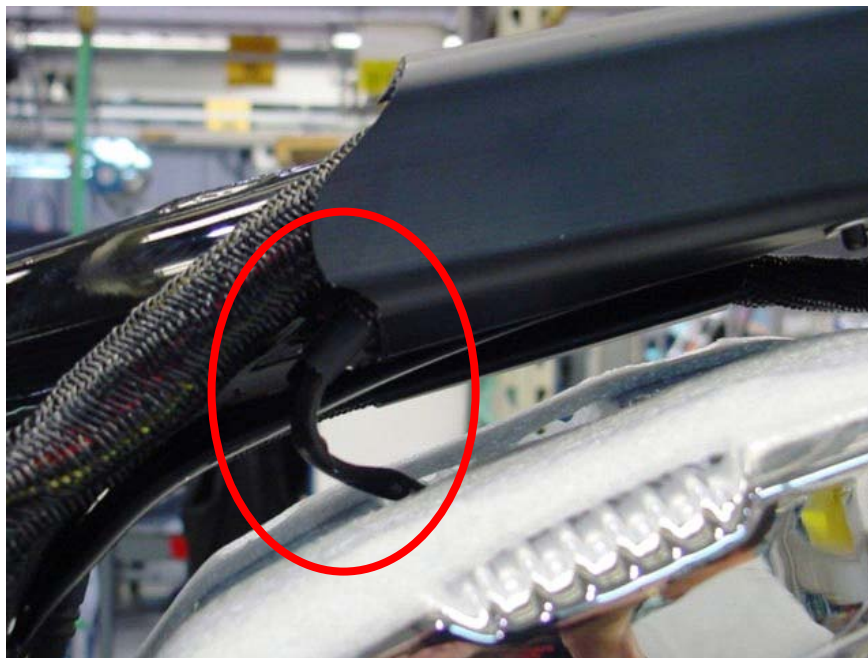
With the introduction of the '07 XL's we have received a few calls regarding the wire routing for the engine temp sensor. Please take the time to verify the routing of the sensor wire to ensure it has enough slack so that the wires are not pulled tight. If the wires are routed incorrectly the wires could be pulled out of the sensor resulting in the bike having a P0118 code.

Shown with the tank removed for clarity

It is not necessary to remove the tank for inspection of the routing. If rerouting is necessary, first attempt to create the loop by gently pulling the slack in the harness towards the cylinder heads. Take care not to pull the wires out of the sensor when rerouting the harness. Tank removal may be needed if the wires are pinched under the fuel tank.
