TT262 – August 28, 2006

Painted Parts

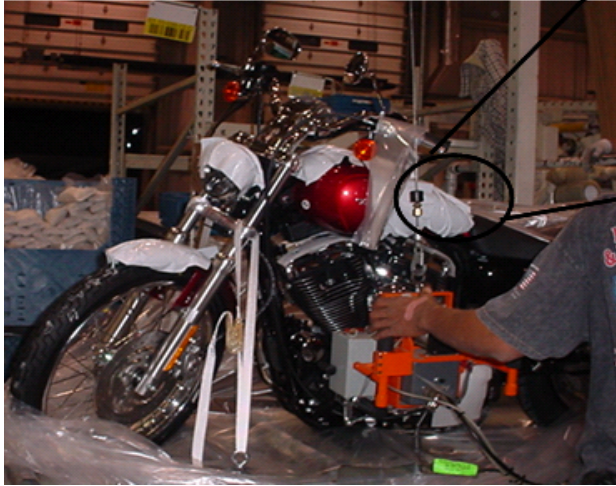
On painted parts a surface condition called “worming” has been reported by the Dealer network. Worming is a surface condition (on top of clear coat) that appears to the Dealer Technician as water marks that will not wipe off.

After investigation the root cause was determined to be packaging / protective tape remaining on the painted part surface in exposed sunlight. Furthermore, this condition was made worse by time in direct sunlight.

Please remove all protective tapes prior to placing product in direct sunlight. If the paint shows this condition you will need to make the repair and use the Light sanding/buff/blend labor code 1104.
