TT270 – October 4, 2006

V-Rod Camshaft Surface Inspection Guidelines

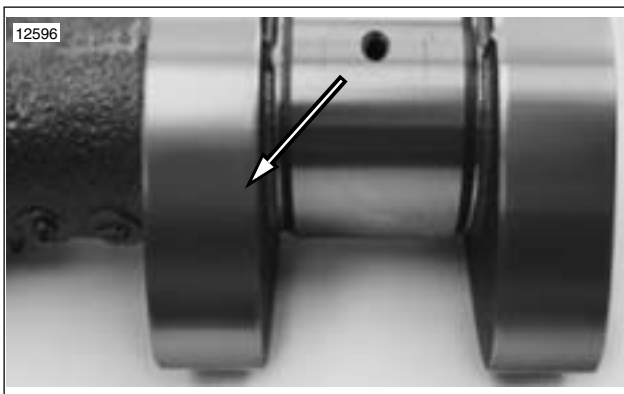
There are two styles of surface finish found on VRSC camshafts. The first is called *camground* which can be seen in [Figure 3-26](#). This lobe appears very smooth. The second finish is called *micro-stoned* which can be seen in [Figure 3-27](#). This lobe will have horizontal finish marks on the lobes from the finishing stone used in the manufacturing process. Both are acceptable finishes on VRSC camshaft lobes.

Figure 3-26. Camground Camshaft Lobes

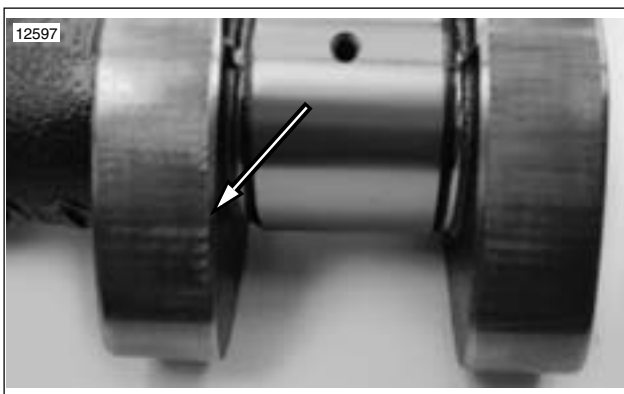
Figure 3-27. Micro-Stoned Camshaft Lobes

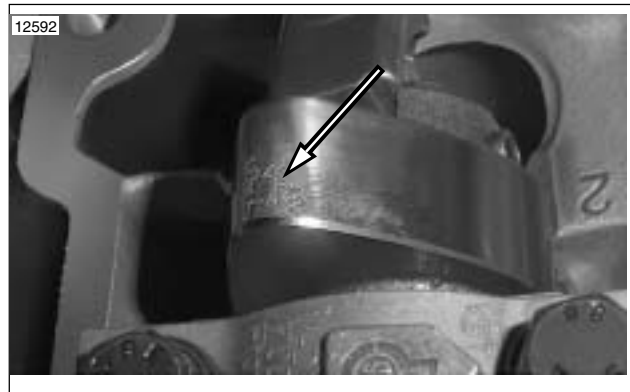
1. See [Figure 3-28](#). This figure shows camshaft spalling within and acceptable specification on the toe of the camshaft lobe.
2. See [Figure 3-29](#). This camshaft shows spalling on the camshaft heel at an unacceptable level as the spalling extends across the entire camshaft lobe.

Figure 3-28. Camshaft Toe Spalling

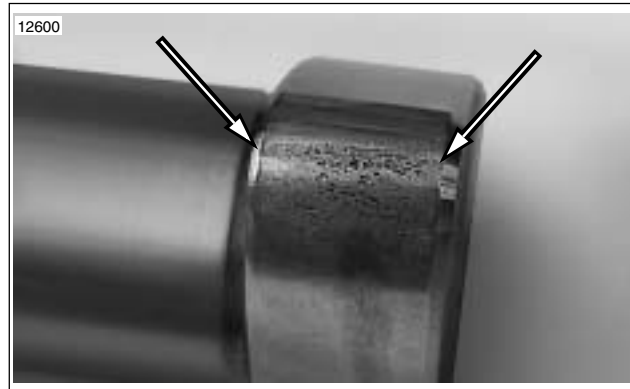
Figure 3-29. Camshaft Heel Spalling

If camshaft lobe exhibits spalling that extends fully across the width of the camshaft lobe or extends past 15 mm beyond the toe of the camshaft lobe in either direction of camshaft travel, replace camshaft.

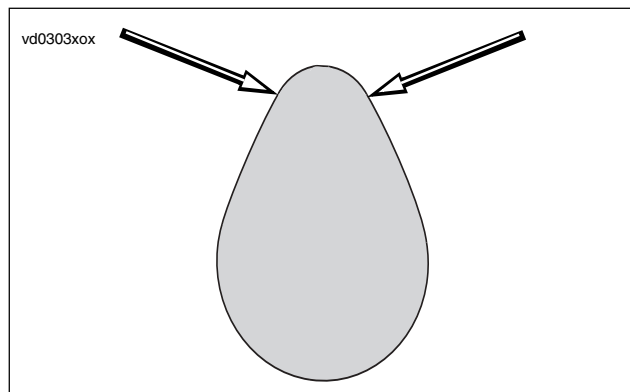
Figure 3-30. Cam Lobe (typical) showing 15 mm from toe of camshaft lobe on each side of lobe
