## **VRSC Updates**

### **Fuel Strainer Sock**

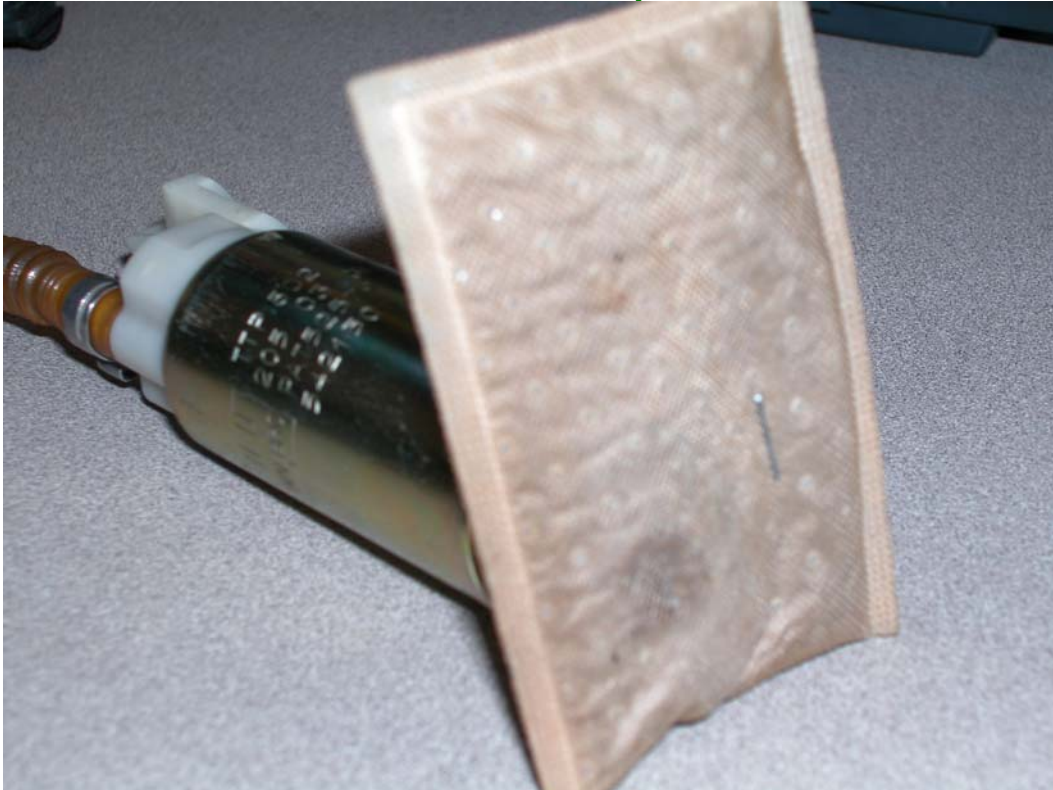
### Fuel Sock Retainer Repositioned

If so, remove the fuel module assembly and inspect the fuel strainer sock. You may see a dime sized dark spot on the face of the sock. (see image below) This indicates the fuel is being restricted and drawn through this very small area. The plastic retainer for the fuel

sock can become dislodged, thereby letting the sock collapse against the pump inlet.

In this case, fuel pump replacement is recommended but there is a lower cost alternative if the customer chooses to repair, instead of replace the part.

Reposition the plastic retainer that is inside the sock, over the pump inlet and staple the fuel sock to prevent the retainer from moving out of position. This should give you full fuel pressure and eliminate the need for replacement pump assembly. (see image below)
