TT396: 1125R Instrument Cluster Software Changes

November 24, 2008

1125R Instrument Cluster Software Changes

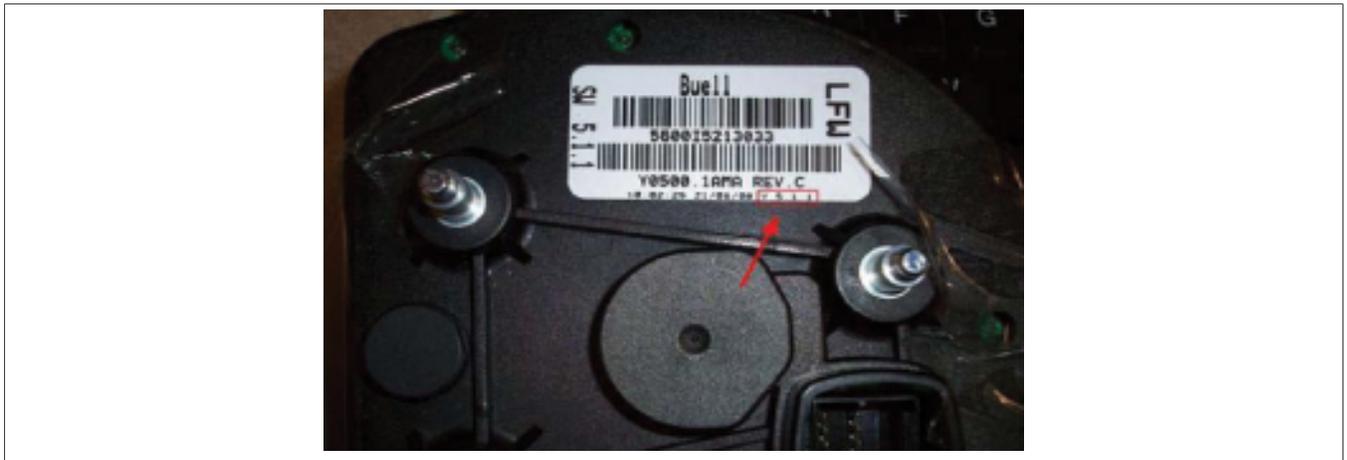
Figure 1.

Buell 1125R models with symptoms of excessive battery draw while parked may require an instrument cluster replacement. A software issue was identified that can keep the security system awake, causing excessive key-off battery draw. The affected clusters were installed on 1125R models produced from October 29, 2007 to May 16, 2008.

Early instrument clusters only display the software level on the rear of the module. (see image below) A software version of 5.1.1 includes upgrades to prevent the abnormal draw and should NOT be replaced for draw related issues.

If you are unable to locate a draw on the vehicle and the cluster software version is below 5.1.1, i.e. 4.1, 4.2, 4.3..., the instrument cluster should be replaced.

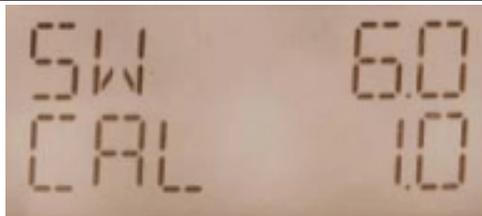
Figure 2. A Software Level of 6.0

Verify the software version as well if you are diagnosing inaccurate low fuel warning lights. Issues were identified with the Software Version 5.1.1 and 6.0 that could lead to a low fuel light coming on intermittently with adequate fuel levels.

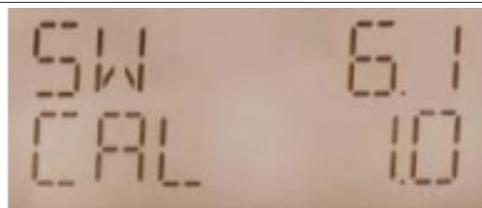
Figure 3. A Software Level of 6.1
